# Annual Inspection Report Jeffrey Energy Center Flue Gas Desulfurization (FGD) Landfill

Westar Energy

Jeffrey Energy Center

January 2018

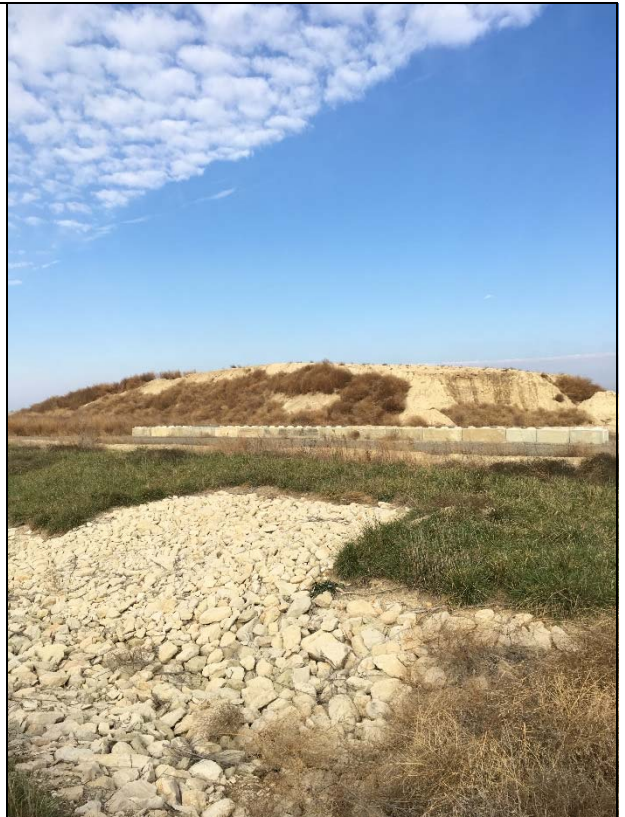
**Photograph No. 1**

View from the perimeter road looking toward the flue gas desulfurization (FGD) landfill with beneficial use pile in center of photograph.

The perimeter stormwater ditch is shown in the foreground. The ditch is lined with rip-rap, which is in good condition. The ditch is free of obstructions and functioning as intended.

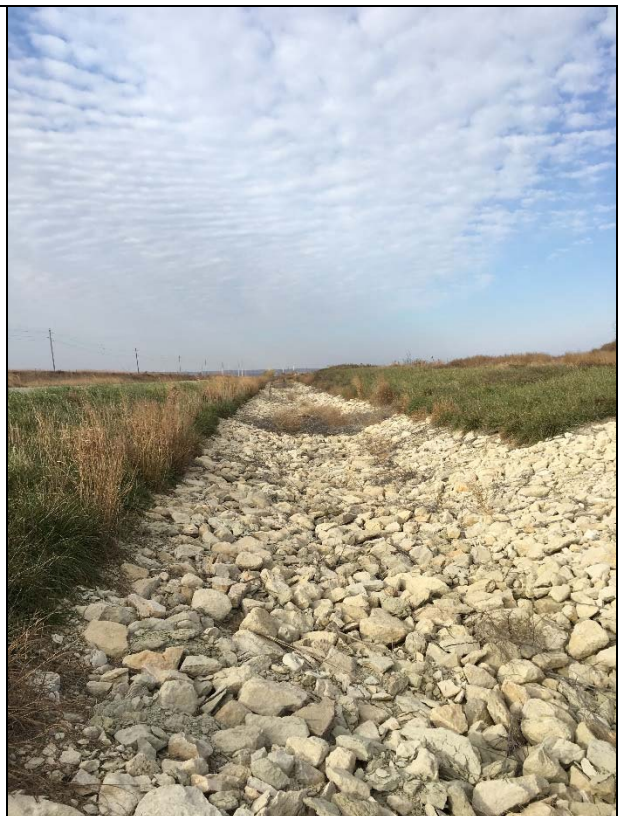
**Photograph No. 2**

Perimeter stormwater ditch lined with rip-rap and final cover of Phase I (right side of photograph). Perimeter ditch is in good condition. Vegetation within ditch has been sprayed with herbicide. Final cover vegetation is well established and maintained. No evidence of erosion or malfunction.

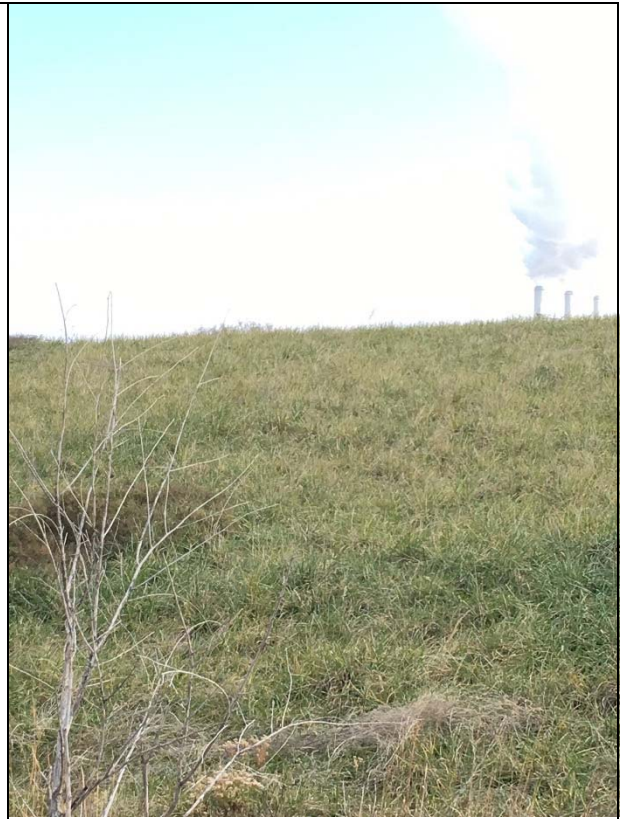
**Photograph No. 3**

Observing the vegetative cover. Vegetation is well established and maintained. No evidence of erosion or malfunction.

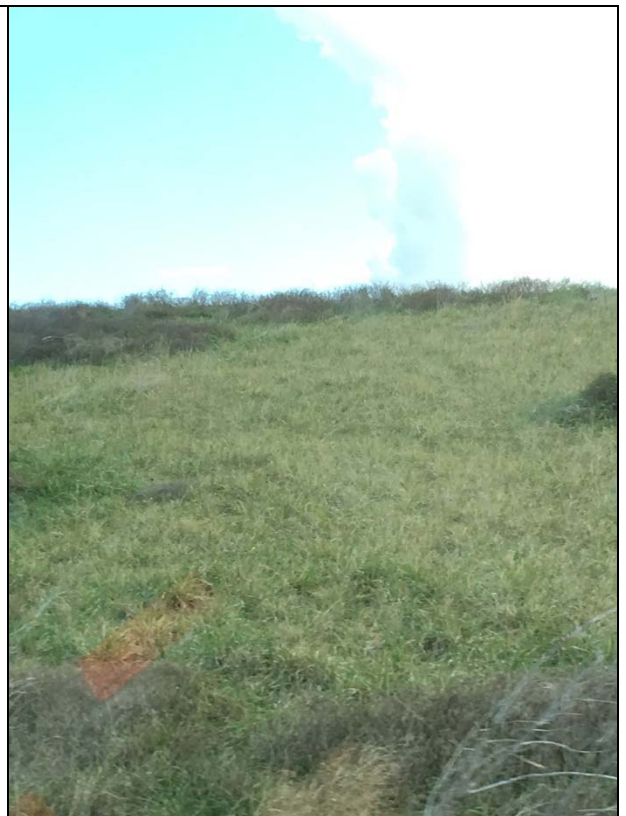
**Photograph No. 4**

Observing the vegetative cover. Vegetation is well established and maintained. No evidence of erosion or malfunction.

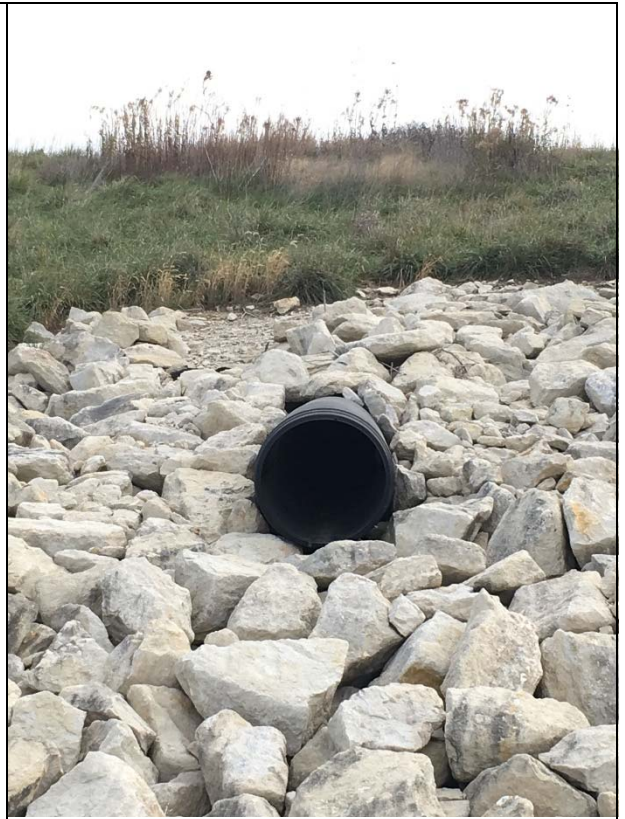
**Photograph No. 5**

Observing a former contact water pipe that has been plugged to prevent contact water from leaving the Landfill area.

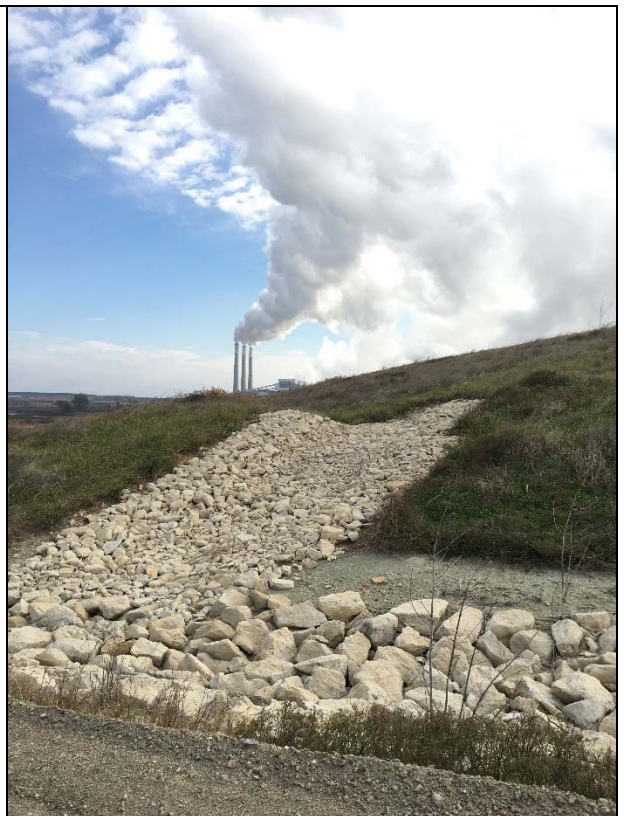
**Photograph No. 6**

Observing a rip-rap lined letdown ditch, stormwater channel, and final cover. No evidence of malfunction or erosion.

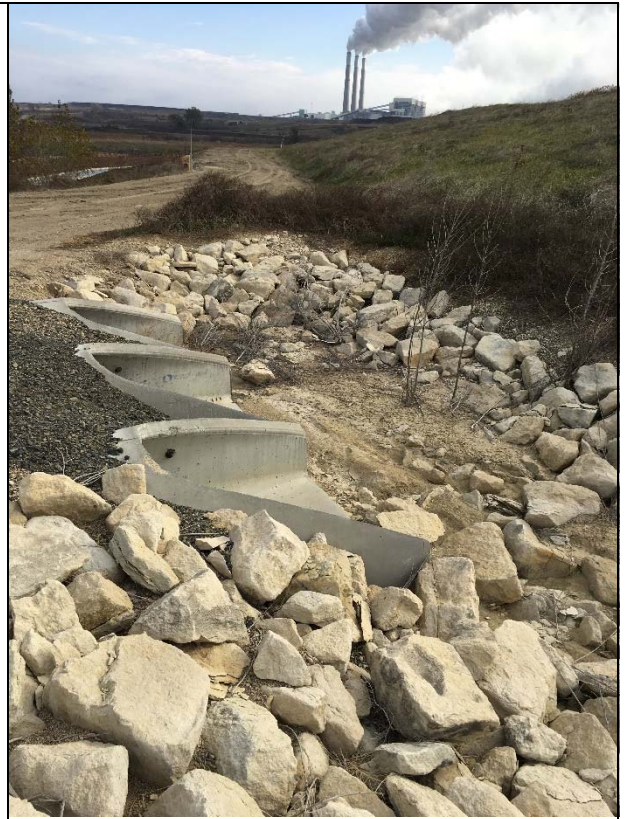
**Photograph No. 7**

Observing perimeter stormwater ditch and road culverts on inlet (Landfill side). No evidence of erosion. However, additional riprap is recommended to be placed at inlet location to prevent future scour.

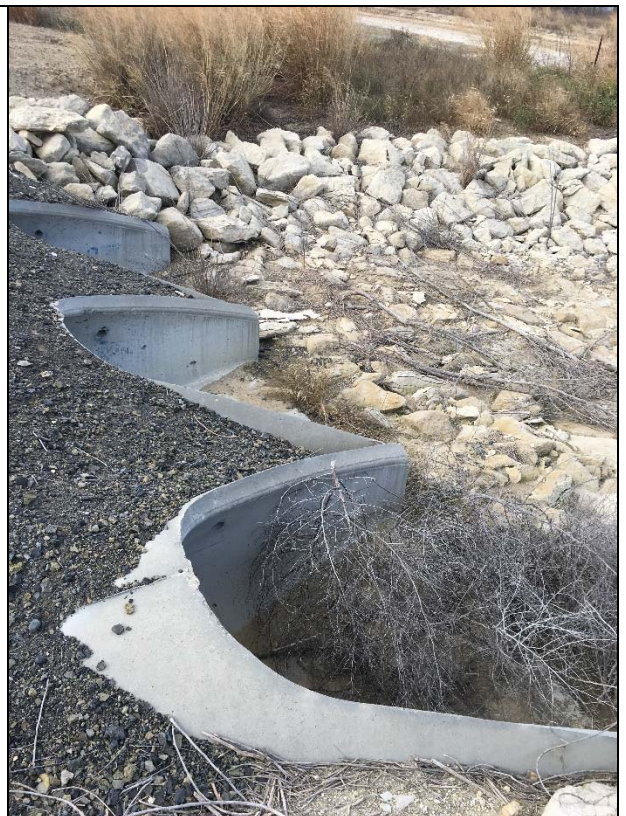
**Photograph No. 8**

Observing perimeter stormwater ditch and road culverts. Some vegetation has accumulated at the culvert outlet that should be removed.

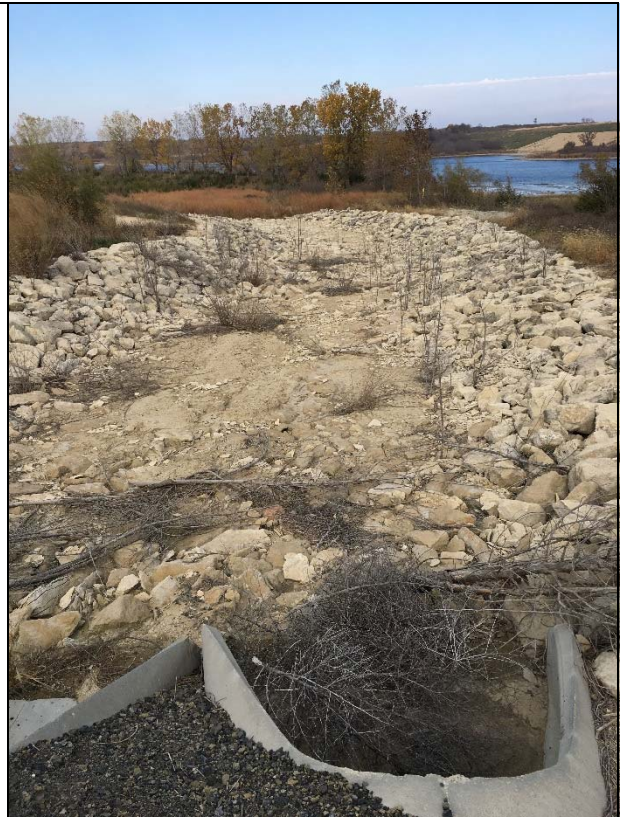
**Photograph No. 9**

Observing perimeter stormwater ditch and road culverts. Some vegetation has accumulated at the culvert outlet that should be removed. Additional rip-rap should be placed to prevent scour as necessary.

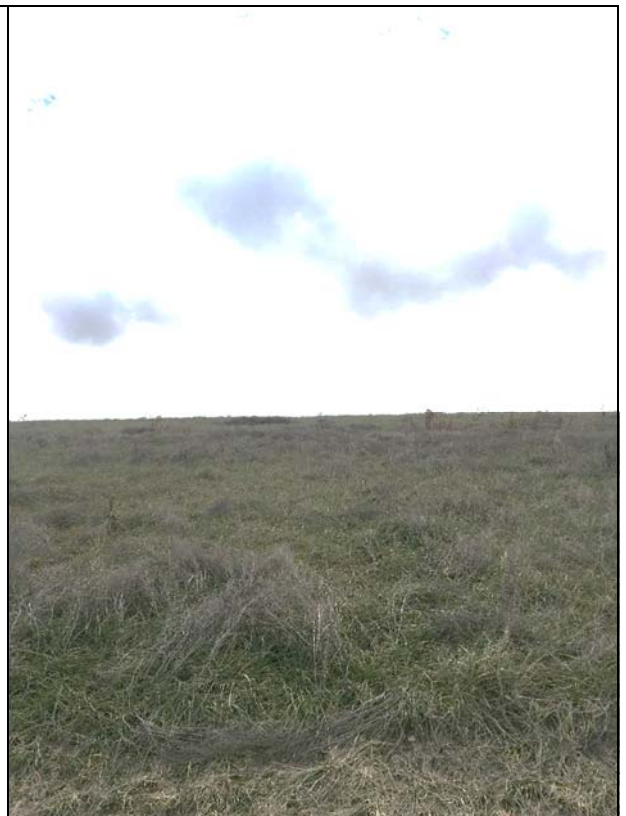
**Photograph No. 10**

Observing the vegetated plateau. Vegetation is well established and maintained. No signs of erosion or sloughing.

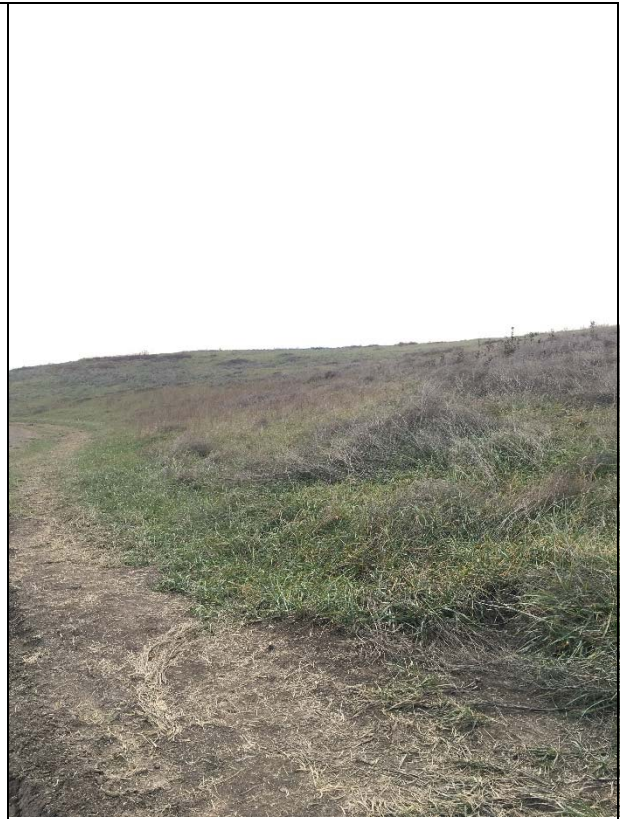
**Photograph No. 11**

Observing the vegetated cover. Vegetation is well established and maintained. No signs of erosion or sloughing.

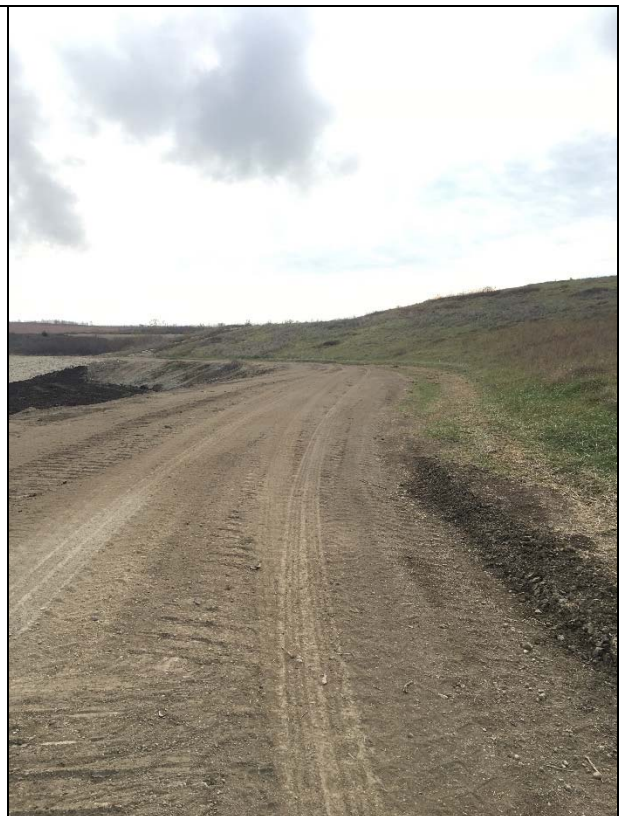
**Photograph No. 12**

Observing the perimeter haul road. Well maintained.

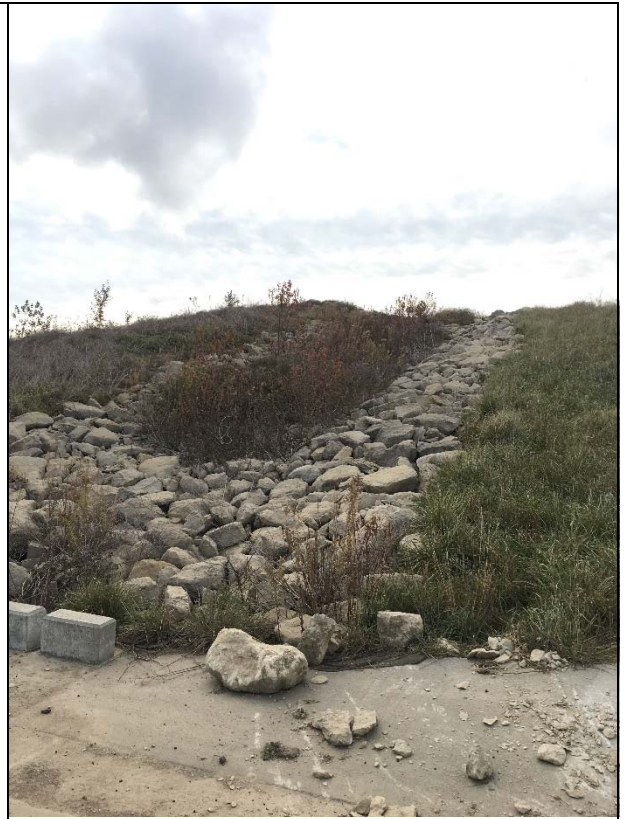
**Photograph No. 13**

Observing a rip-rap lined letdown ditch and concrete road crossing. Vegetation is growing within the rip-rap. This vegetation should be sprayed with herbicide to be removed.

- Excavate and remove crack shown in Photograph 23. Repair berm with structural fill (which may be FGD material).
- Remove vegetation in riprap lined letdown channels to prevent flow obstructions (see Photograph 13).
- Remove vegetation, which has accumulated in the culvert outlet (see Photograph 8).
- Additional rip-rap is recommended to be installed at the culvert inlets and outlets, as shown in Photographs 7-9.
- Continue to monitor erosion controls and vegetative cover in line with routine inspections.
- Continue proper management of the active Landfill areas.
- Continue to monitor all stormwater conveyance features for signs of erosion or malfunction in line with routine inspections.

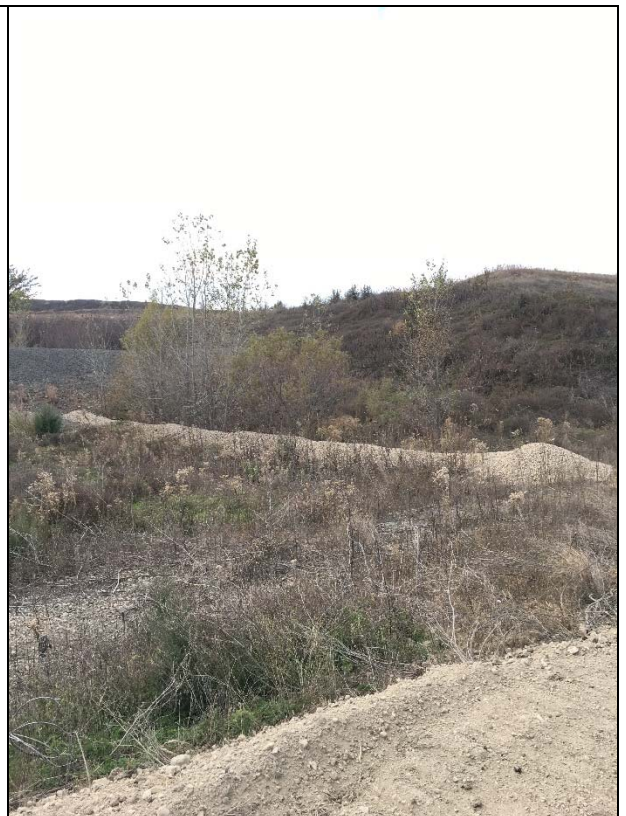
**Photograph No. 14**

Observing a gravel check dam along the non-contact water stormwater ditch. No evidence of erosion or sloughing along drainage way.

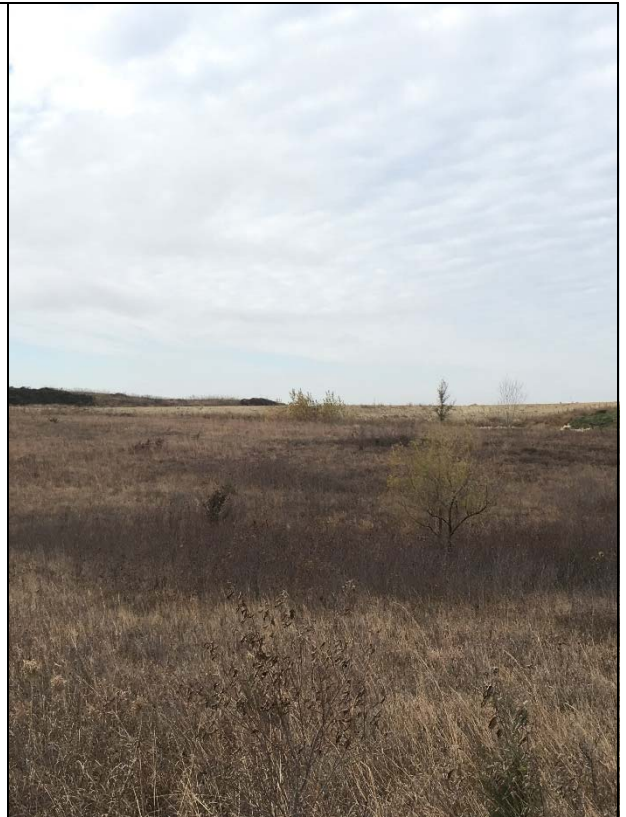
**Photograph No. 15**

Observing FGD area where vegetation has become established. No signs of erosion or sloughing.

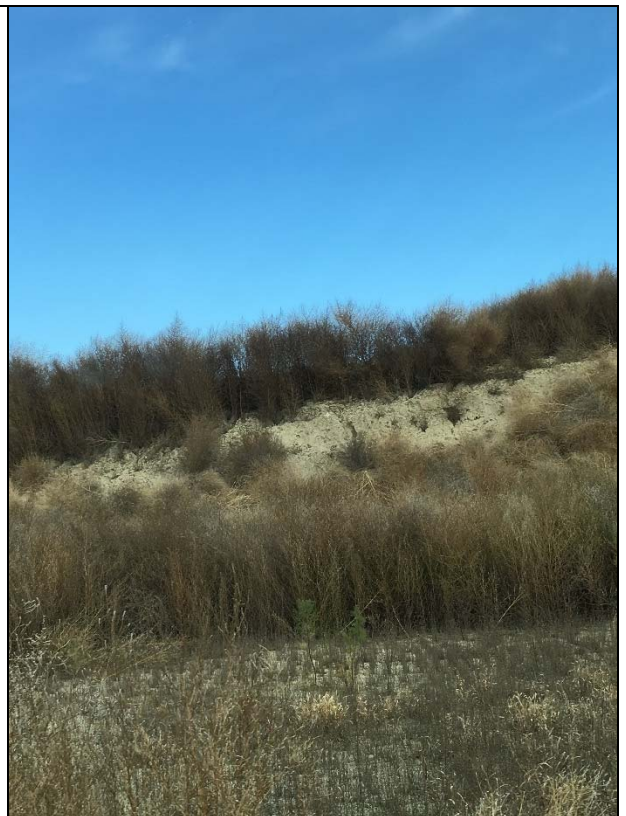
**Photograph No. 16**

Observing the FGD beneficial use pile. No evidence of erosion or sloughing. Vegetation has become established on pile.

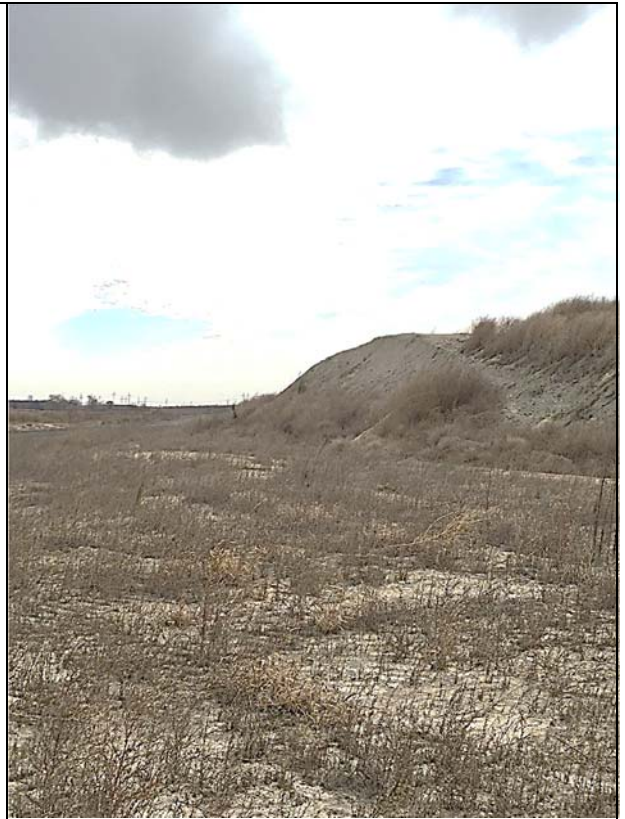
**Photograph No. 17**

Observing the FGD beneficial use pile. No evidence of erosion or sloughing. Vegetation has become established on pile.

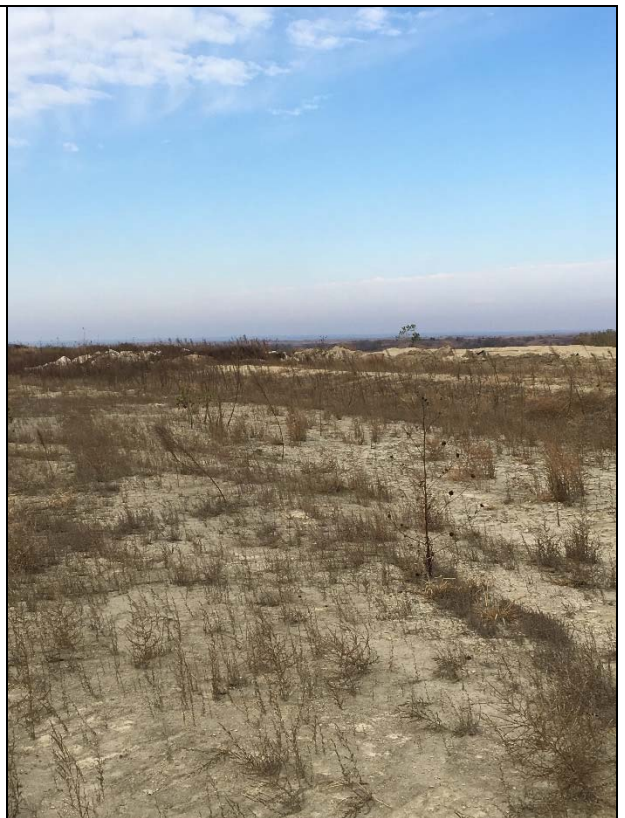
**Photograph No. 18**

Observing the FGD waste disposal face. Vegetation has become established due to minimal disposal quantities.

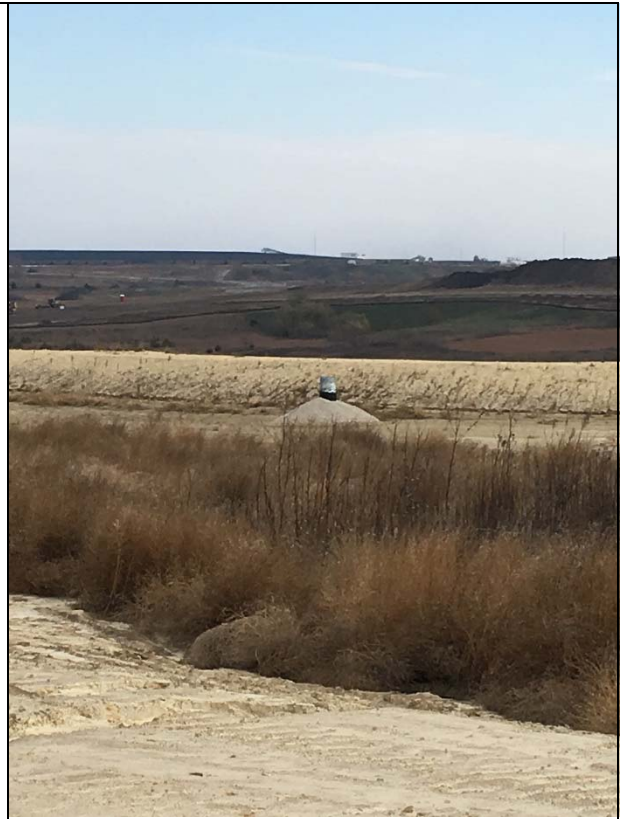
**Photograph No. 19**

Observing the FGD active area and chimney drain pipe. The pipe is installed in low area.

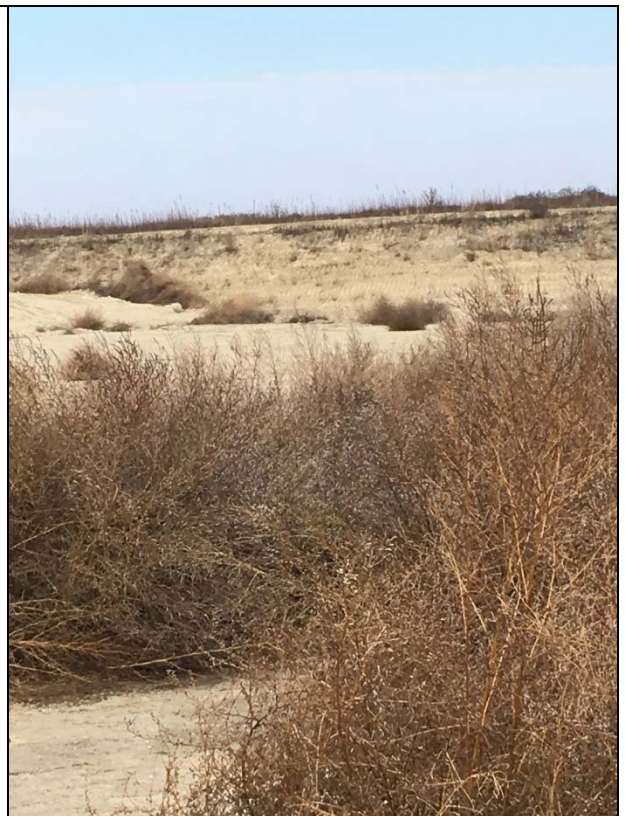
**Photograph No. 20**

Observing the recently graded FGD active area. No dust is being generated. Vegetation is present.

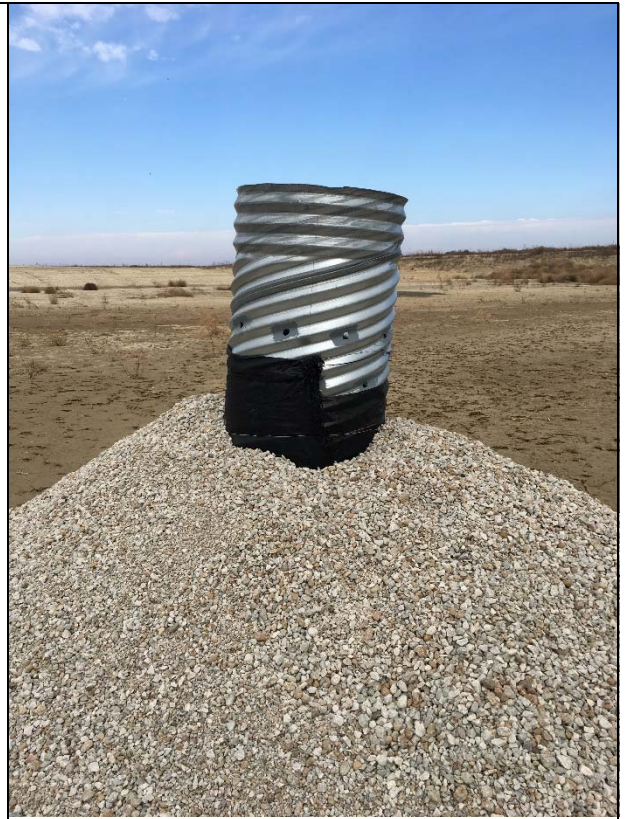
**Photograph No. 21**

Observing the FGD active area and chimney drain pipe.

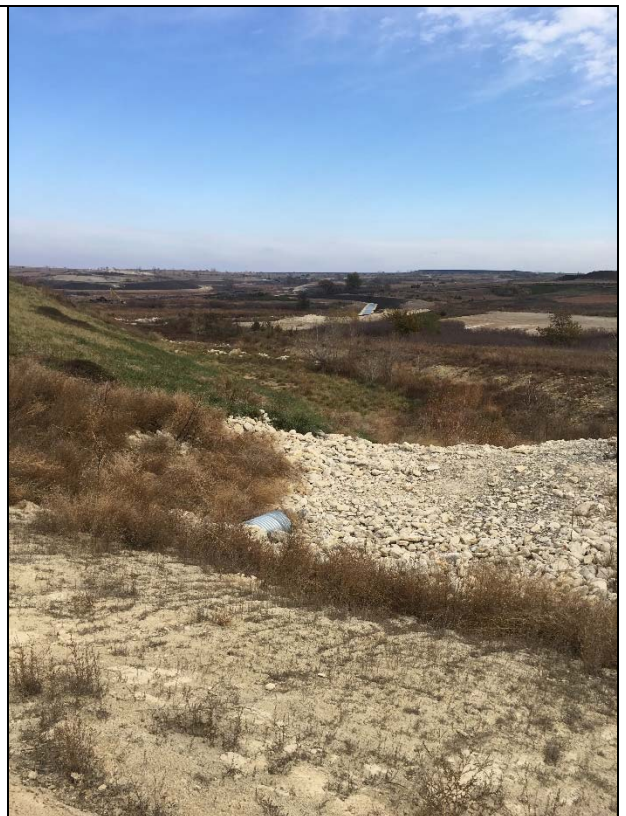
**Photograph No. 22**

Standpipe and rip-rap lined check dam. Vegetation is well established and maintained. No evidence of erosion or malfunction.

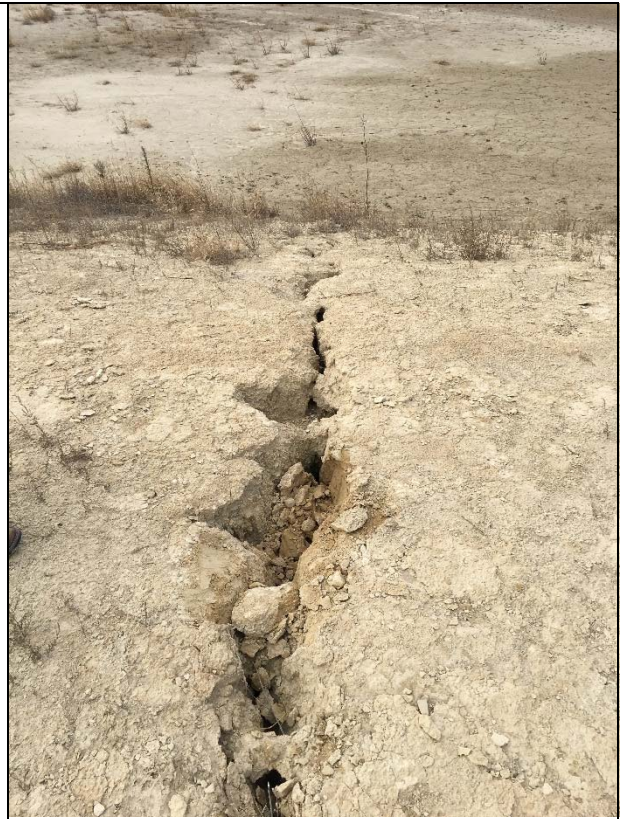
**Photograph No. 23**

One crack was observed on an internal berm (see Photograph 23). It is recommended that this crack be excavated until it is no longer present and repaired with structural fill, which may include FGD material.

There have been no changes to the Landfill that pose a threat or concern to the stability of the landform. However, a crack on an internal berm shown in Photograph 23 does pose a stability concern on this berm. This crack is recommended to be removed and repaired with structural fill (which may be FGD material). Landfill operations and maintenance have not deviated from the original designed plan.

Observing a crack on internal berm that is used for contact water containment. Crack will need repair.

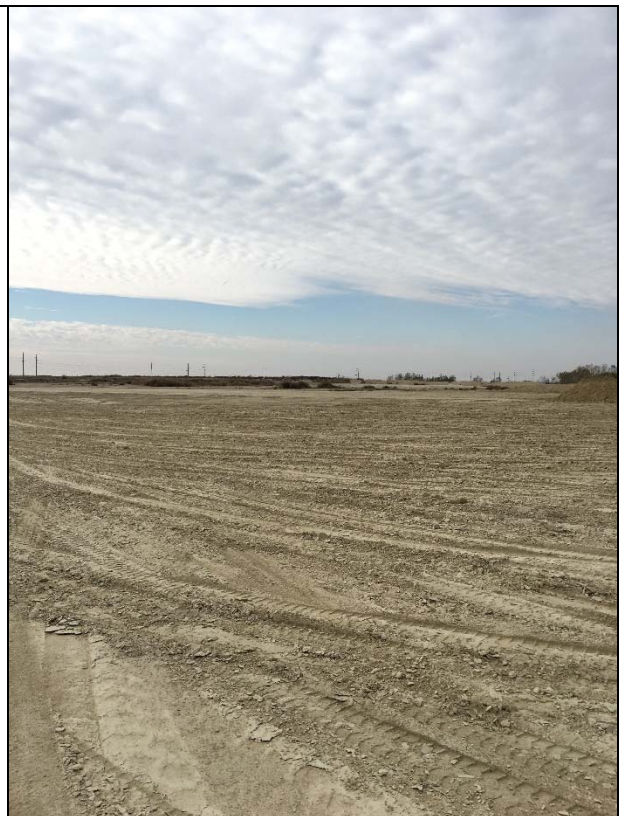
**Photograph No. 24**

Observing the recently graded FGD active area. No ponding water, well maintained.
