# Annual Inspection Report Jeffrey Energy Center Fly Ash Landfill

Westar Energy

Jeffrey Energy Center

January 2018

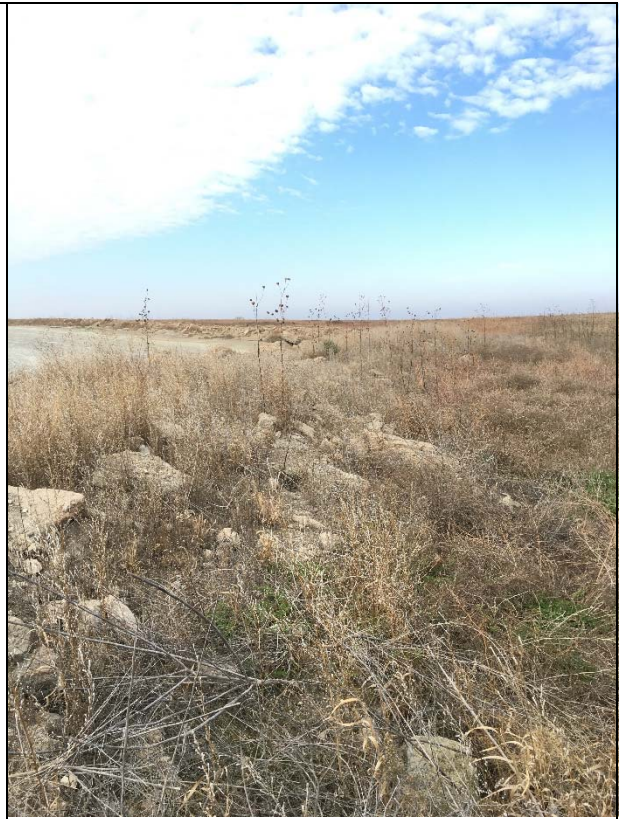
**Photograph No. 1**

Fly ash berms have been completed from last year. Vegetation has been established.

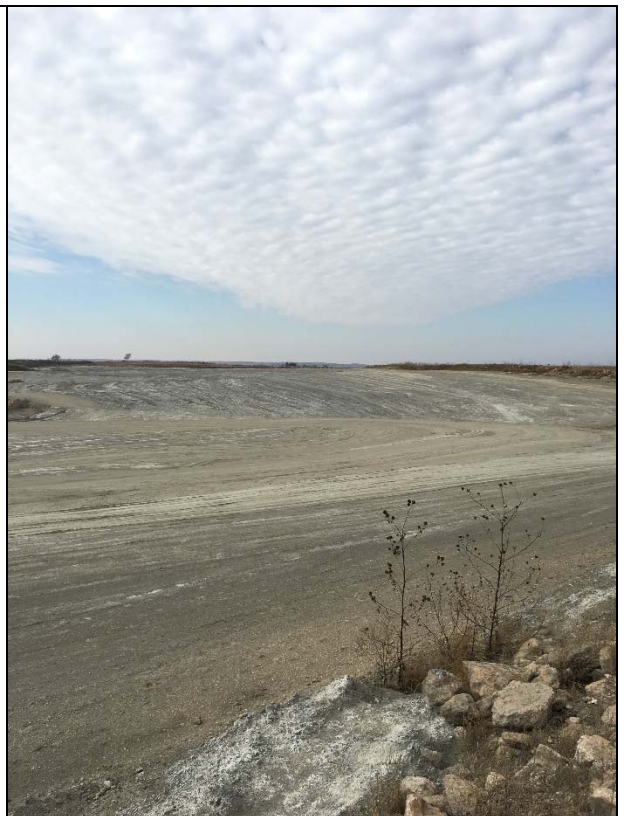
**Photograph No. 2**

Observing active fly ash area operations and maintenance. No evidence of ponding or airborne dust.

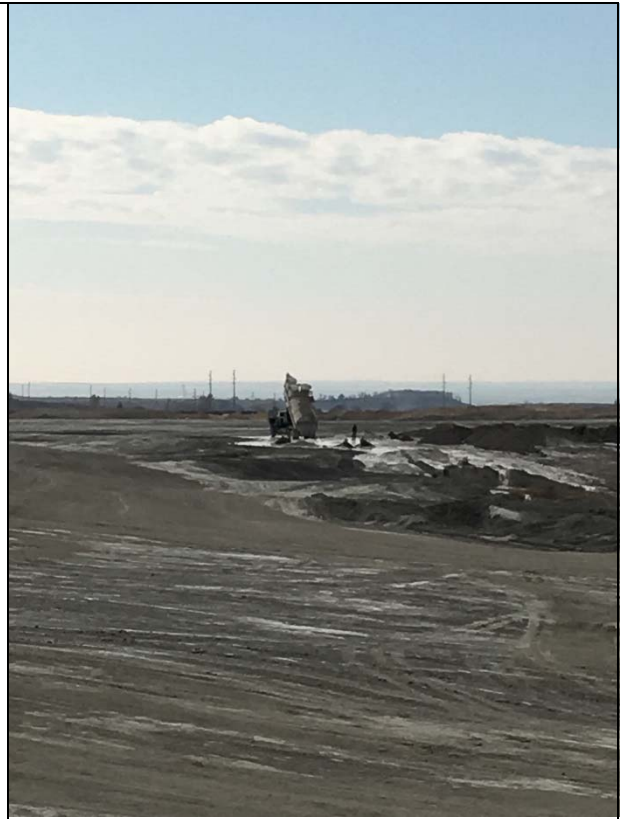
**Photograph No. 3**

Observing active fly ash area operations and maintenance.  
No evidence of ponding or airborne dust.

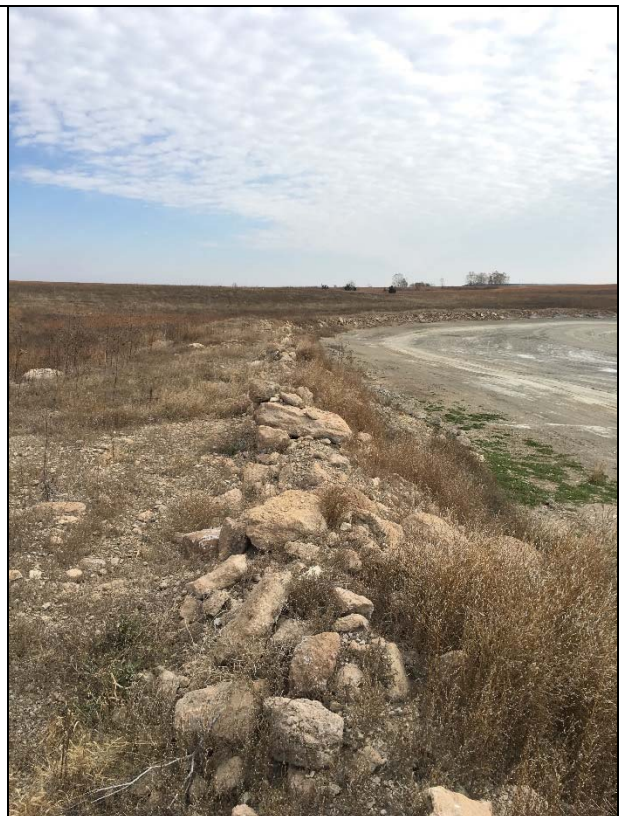
**Photograph No. 4**

Observing the stormwater diversion berm section.  
Vegetation is well established and maintained.

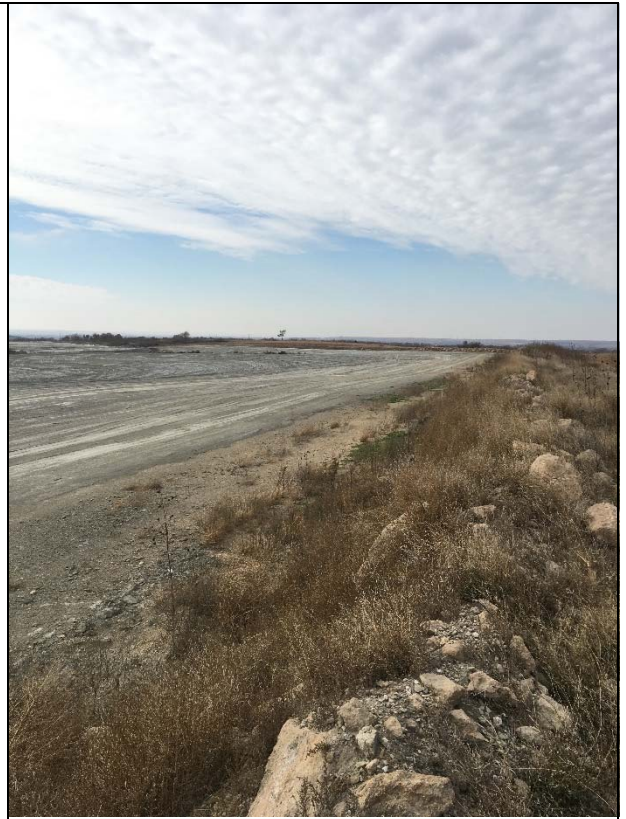
**Photograph No. 5**

Observing the stormwater diversion berm section. Vegetation is well established and maintained.

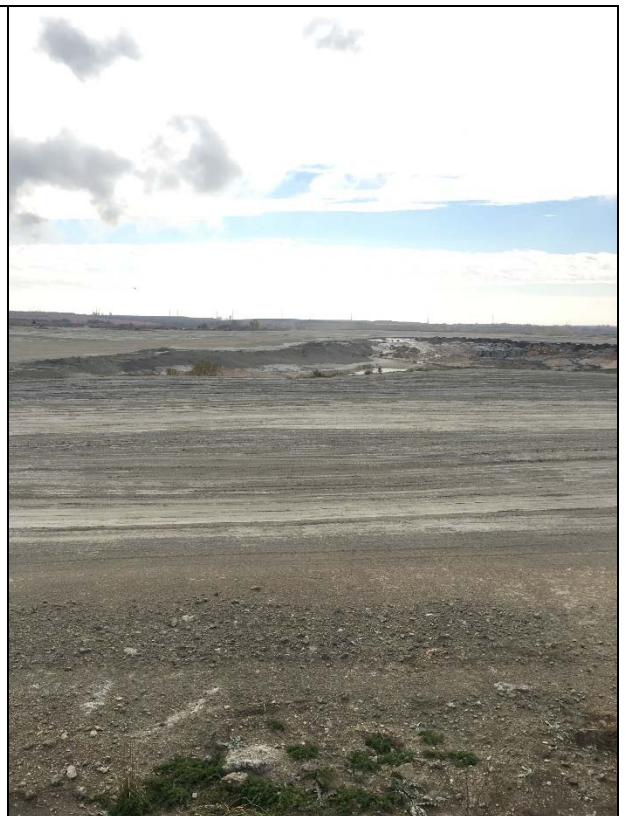
**Photograph No. 6**

Observing active fly ash area operations and maintenance. No evidence of ponding or airborne dust.

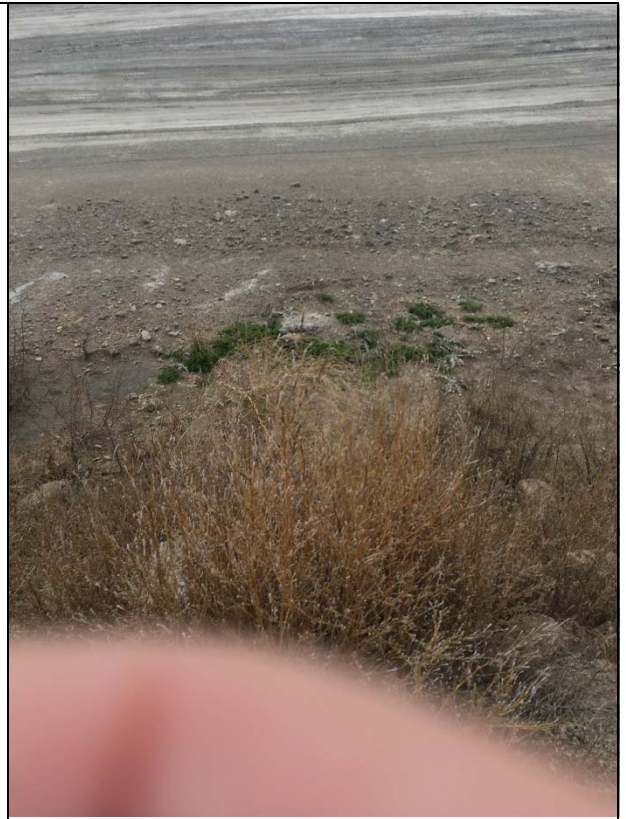
**Photograph No. 7**

Observing active fly ash area operations and maintenance. No evidence of ponding or airborne dust.

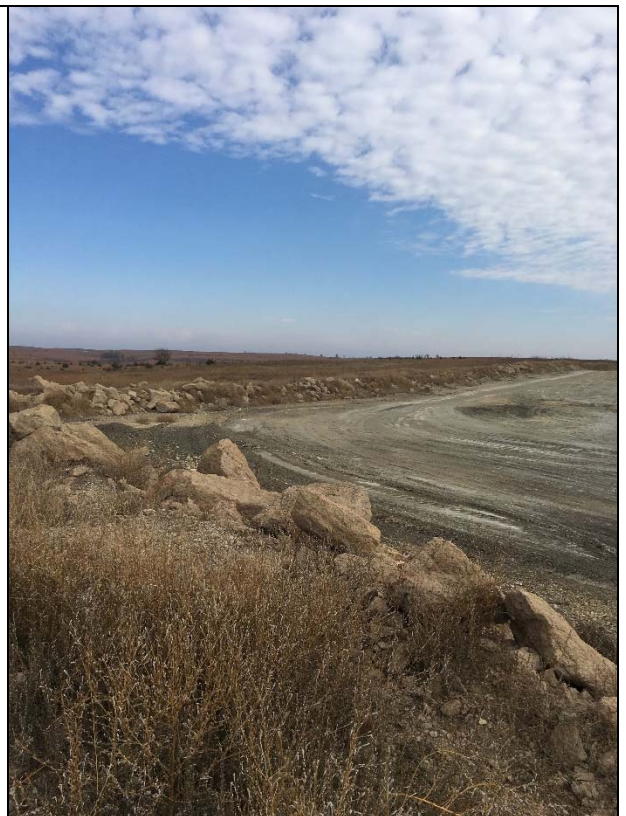
**Photograph No. 8**

Observing the stormwater diversion berm section. Vegetation is well established and maintained.

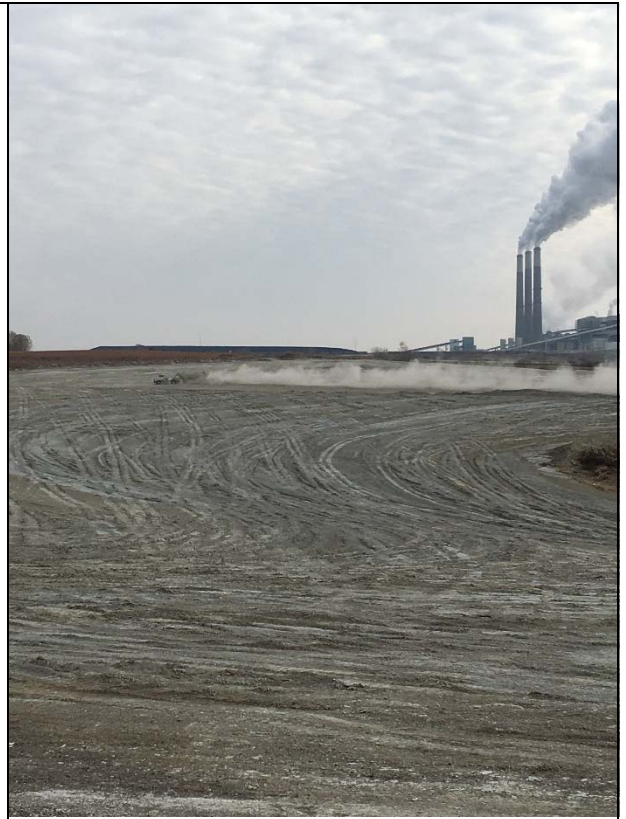
**Photograph No. 9**

Observing active fly ash area operations and maintenance. Slight evidence of airborne dust, however no dust appears to be leaving the Landfill area

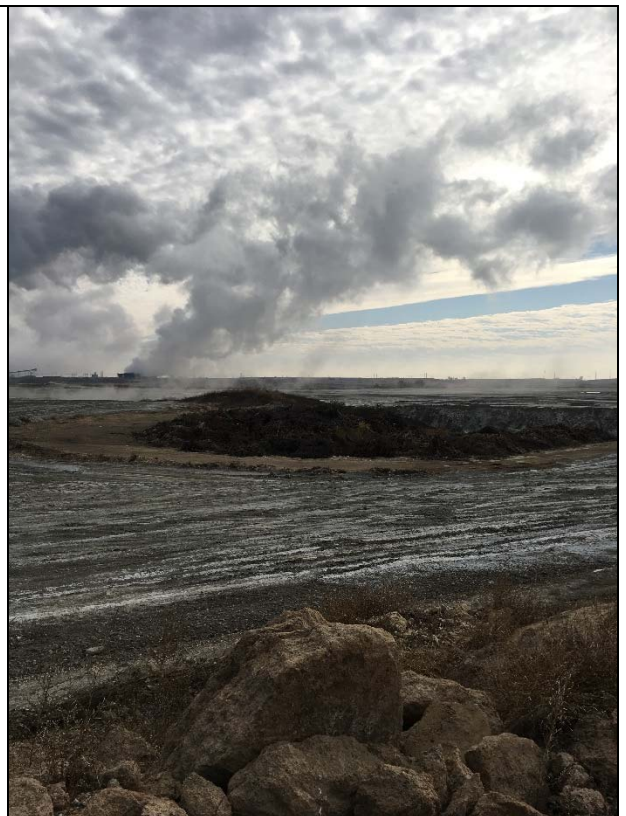
**Photograph No. 10**

Observing the fly ash area vegetative pile.

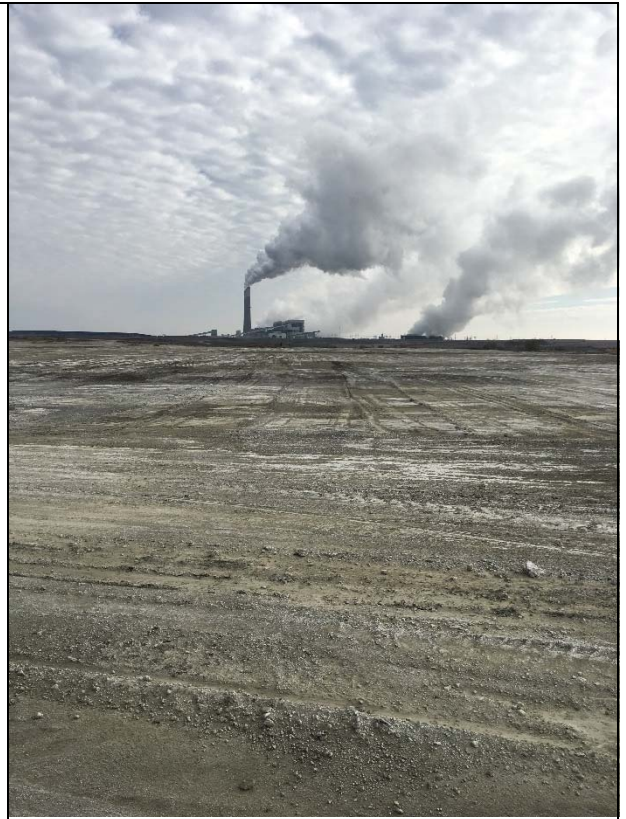
**Photograph No. 11**

Observing active fly ash area operations and maintenance.  
No evidence of ponding or airborne dust.

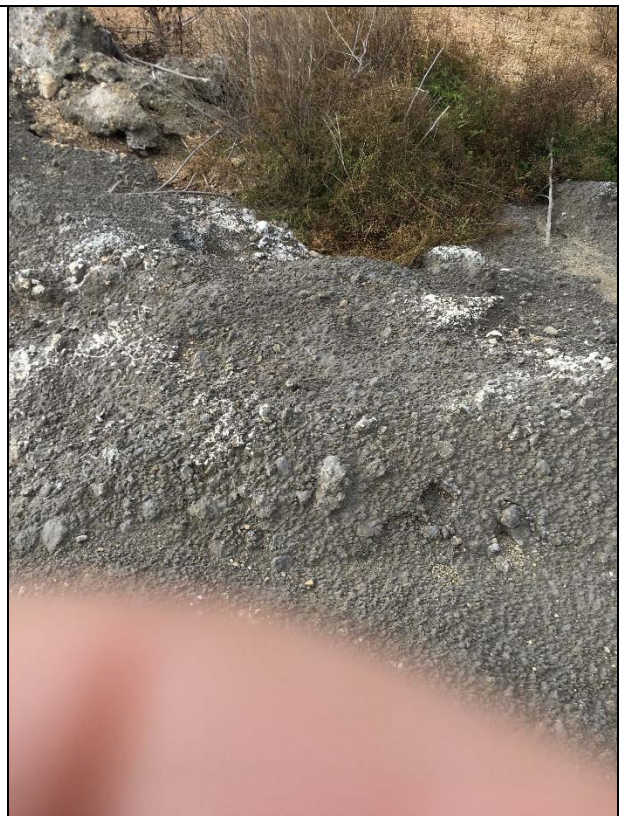
**Photograph No. 12**

Observing active fly ash area operations and maintenance.  
No evidence of ponding or airborne dust.

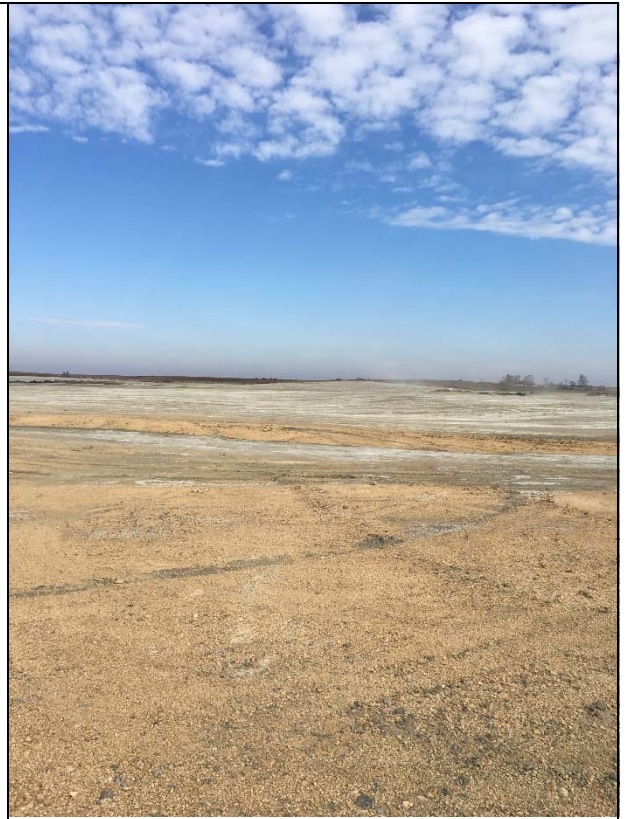
**Photograph No. 13**

Observing active fly ash area operations and maintenance. No evidence of ponding or airborne dust.

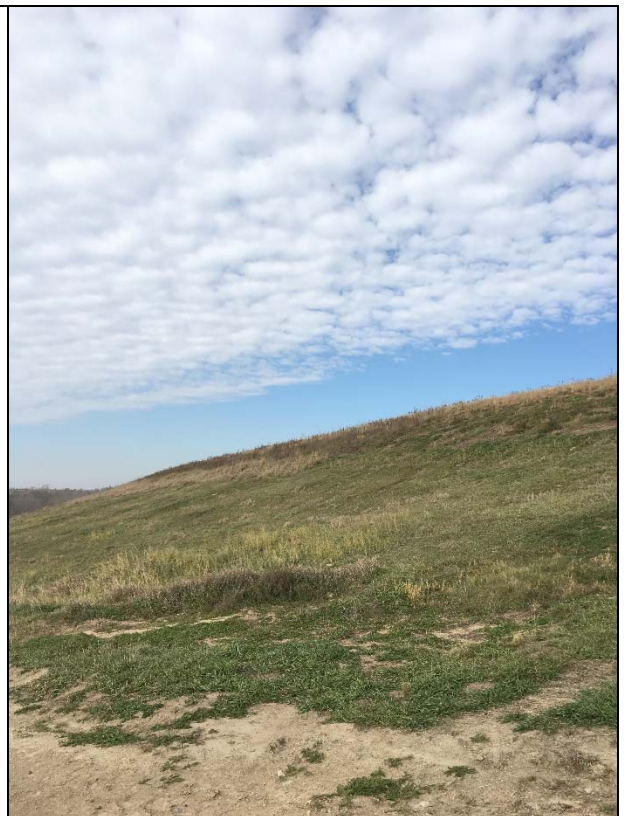
**Photograph No. 14**

Based on a review of the 2016 Annual Inspection Report, it noted that there were two areas of shallow sloughing on the south berm. The sloughing stabilization repairs were completed during the 2016/2017 construction seasons. Repairs included regrading as necessary and the placement of riprap in sloughing areas to prevent future erosion that may result from seepage. This approach is appropriate to address the area of sloughing on the southern berm.

Observing landfill sideslope. Vegetation is well established and maintained. No evidence of erosion or malfunction. Previous sloughing described in 2016 Annual Inspection Report was repaired.

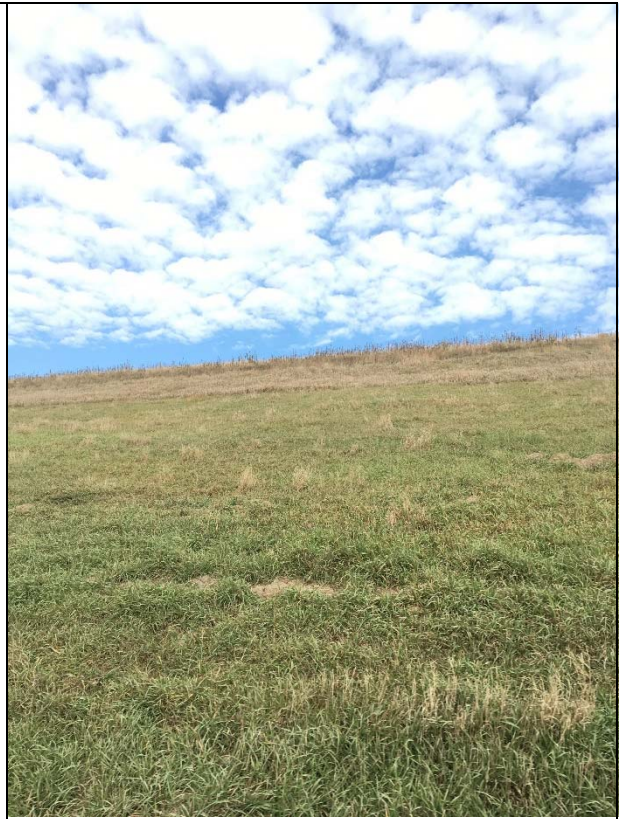
**Photograph No. 15**

Observing landfill side slope. Vegetation is well established and maintained. No evidence of erosion or malfunction at this location.

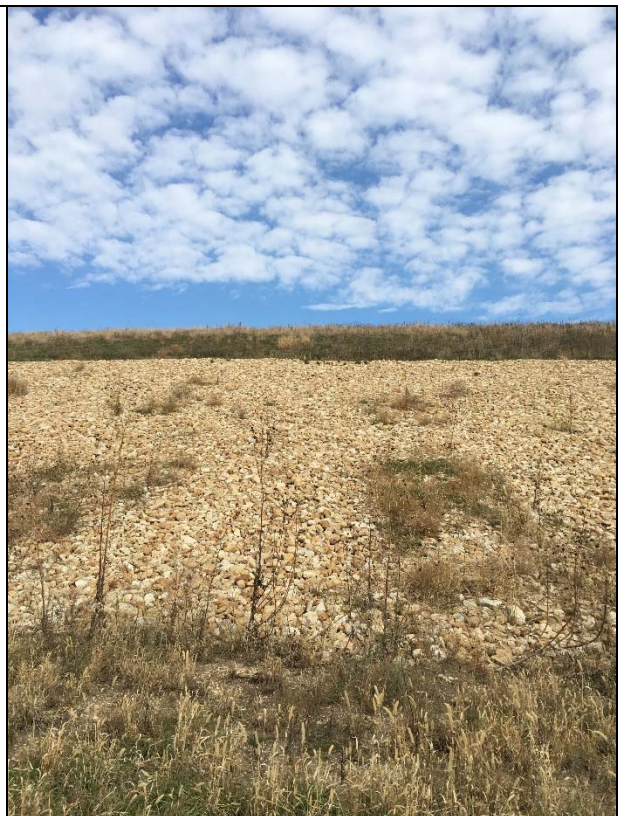
**Photograph No. 16**

Observing landfill side slope. It was noted to have area of sloughing erosion in 2016 Annual Inspection Report. Riprap was added where sloughing seep was fixed. No evidence of erosion or malfunction at this location currently.

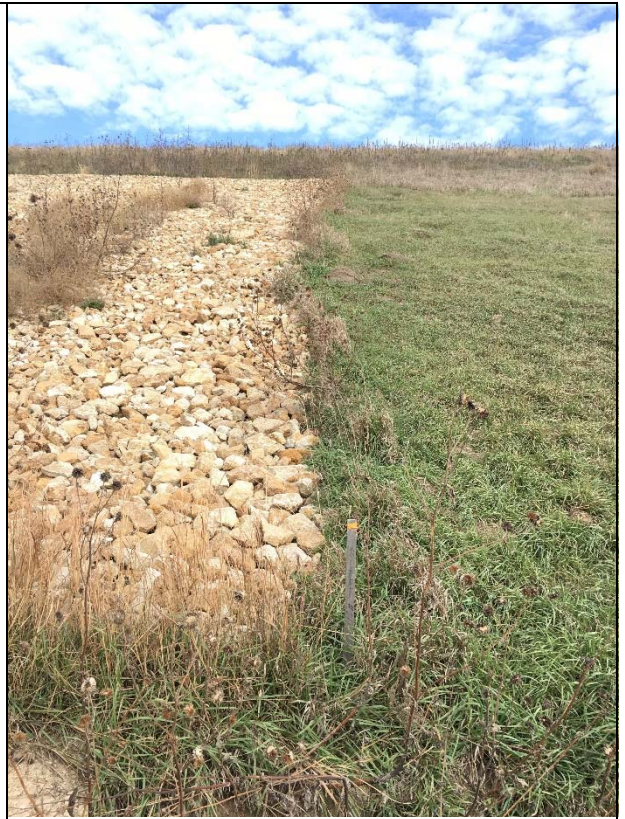
**Photograph No. 17**

The areas that were repaired in 2016 to mitigate seepage/sloughing near the toe of slope appear to be functioning as intended. No slope movement was observed. The area appeared well maintained.

Observing limits of slope repair. Riprap was added where sloughing seep was fixed, as noted in the 2016 Annual Inspection Report. No evidence of erosion or malfunction at this location currently.

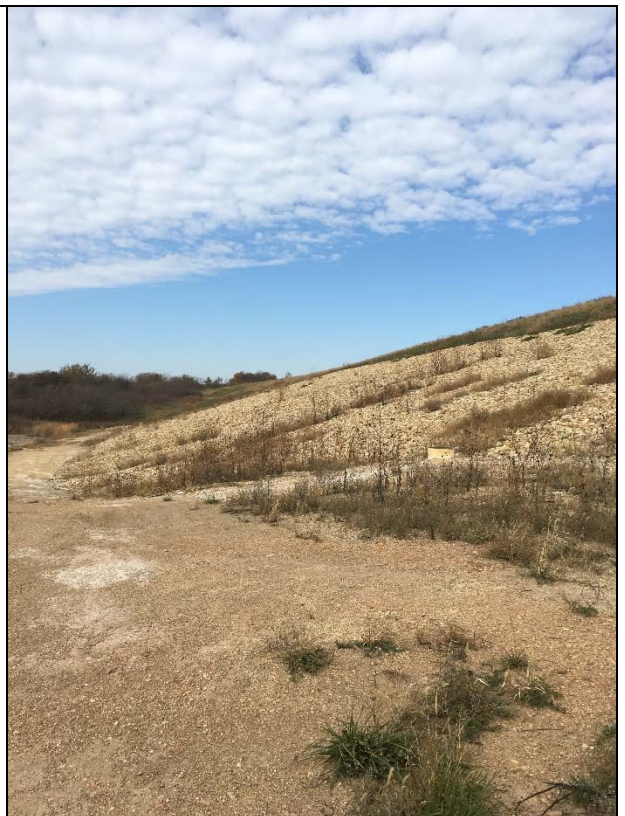
**Photograph No. 18**

Observing limits of slope repair. Riprap was added where sloughing seep was fixed, as noted in the 2016 Annual Inspection Report. No evidence of erosion or malfunction at this location currently.
