# Annual Inspection Report Tecumseh Energy Center Industrial Landfill #0322

Prepared for:  
Westar Energy  
Tecumseh Energy Center  
Tecumseh, Kansas

Prepared by:  
APTIM Environmental & Infrastructure, Inc.

January 2018

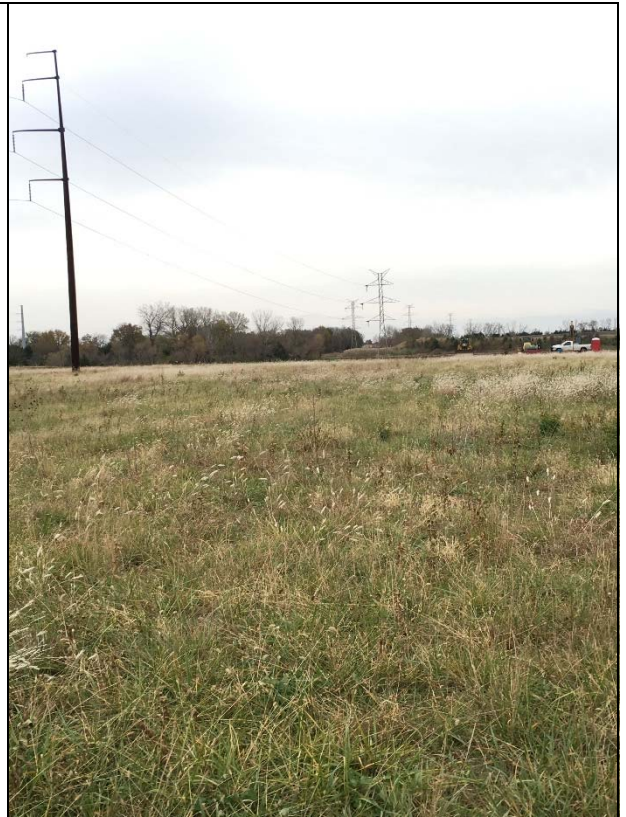
**Photograph No. 2**

Vegetated cover on plateau area of Phase 1. Vegetation is well established and maintained. No evidence erosion, ponding, or animal burrows. No stability concerns.

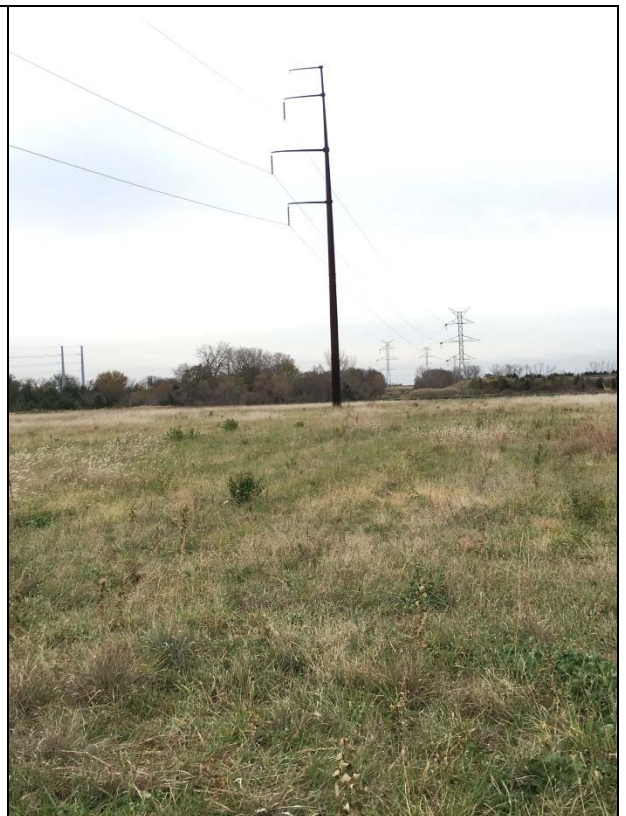
North slope of Phase 1. Vegetation is well established and maintained. No evidence of sloughing, tensile cracking, or other indications of stability concerns.

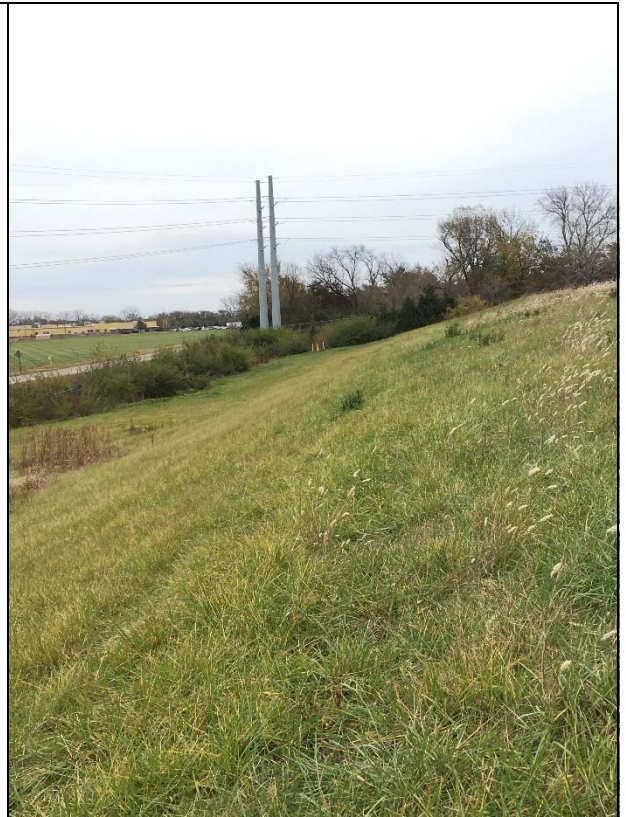
**Photograph No. 4**

North slope of Phase 1. Vegetation is well established and maintained. No evidence of sloughing, tensile cracking, or other indications of stability concerns.

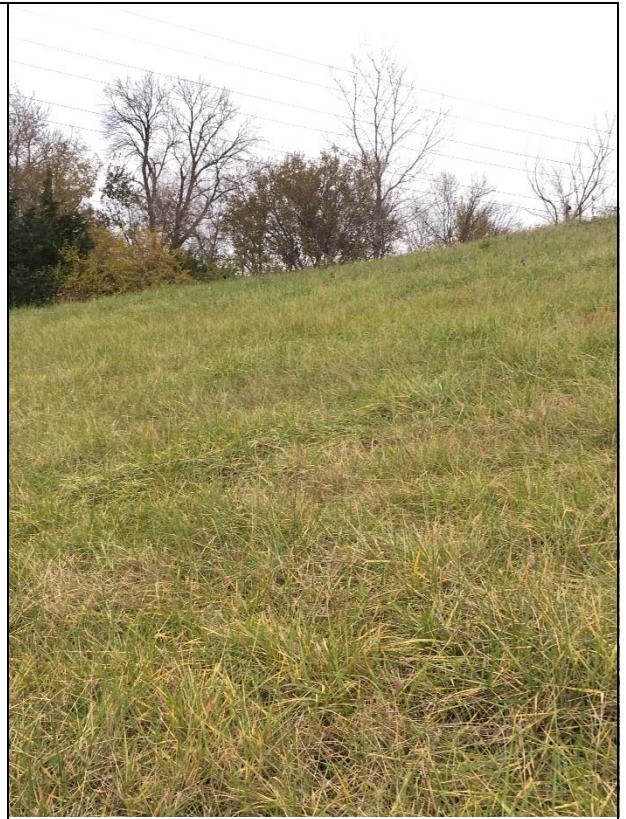
**Photograph No. 8**

Vegetated cover on plateau area of Phase 1. Vegetation is well established and maintained. No evidence erosion, ponding, or animal burrows. No stability concerns.

Construction equipment in the background are located on Phase 3 plateau, where the former contact water management basin has been filled to surrounding grade with structural fill.

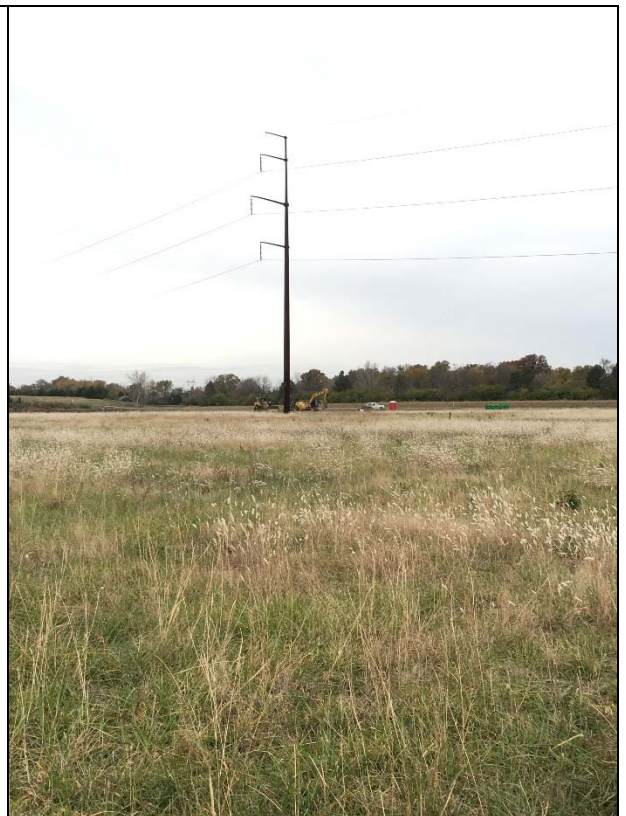
Vegetated cover on plateau area of Phase 1. Vegetation is well established and maintained. No evidence erosion, ponding, or animal burrows. No stability concerns.

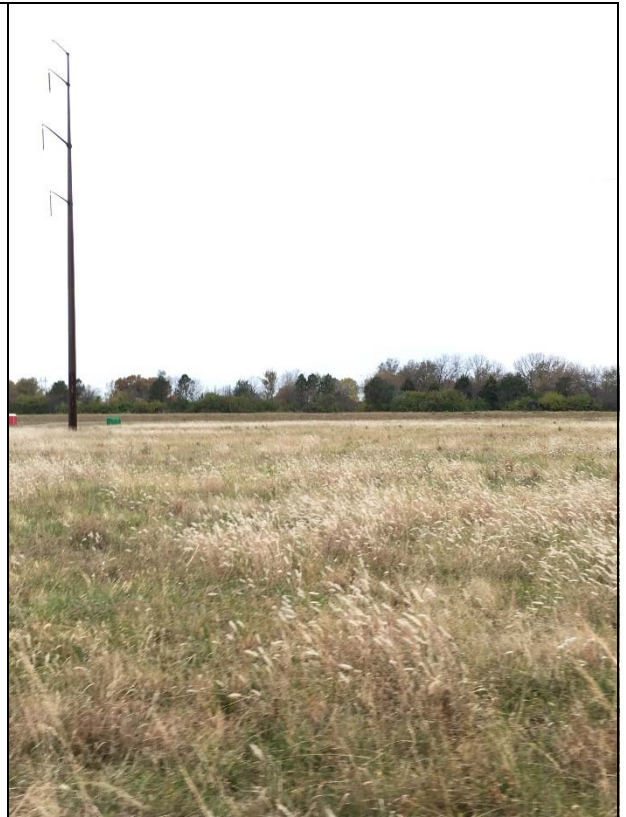
**Photograph No. 10**

North slope of Phase 1 with MW-6 in background. Vegetation is well established and maintained. No evidence of sloughing or tensile cracking.

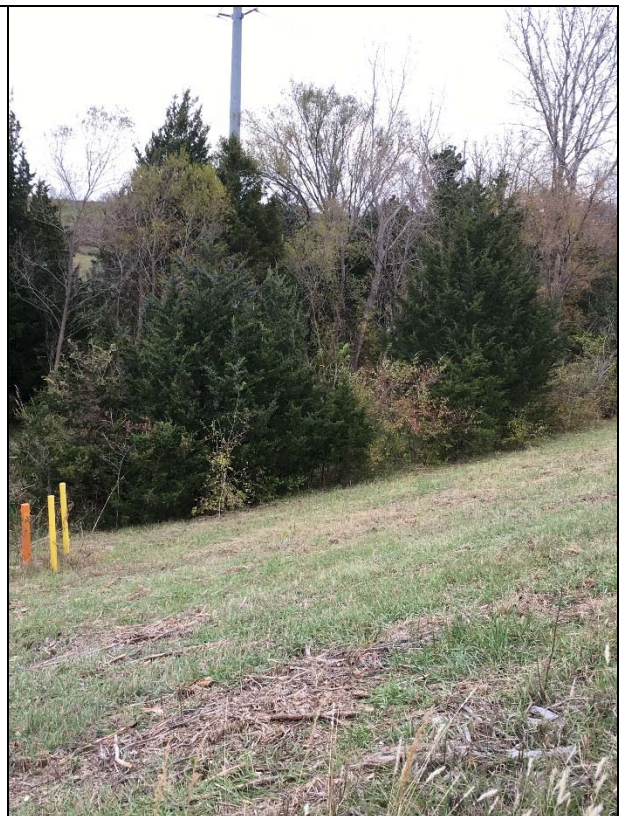
East slope of Phase 3. Vegetation is well established and maintained. No evidence of sloughing, tensile cracking, or other indications of stability concerns.

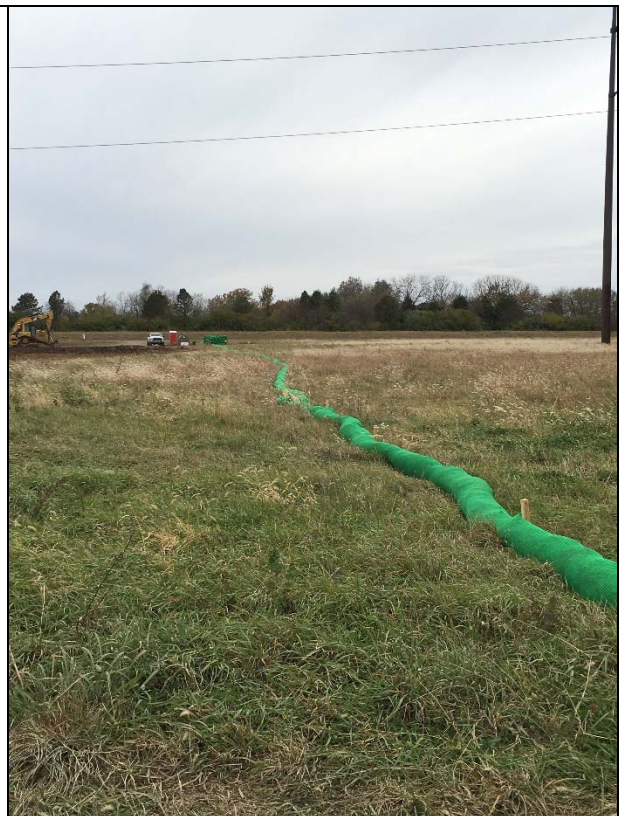
Wattle around the final cover construction area of Phase 3 is appropriately installed to prevent sediment migration.

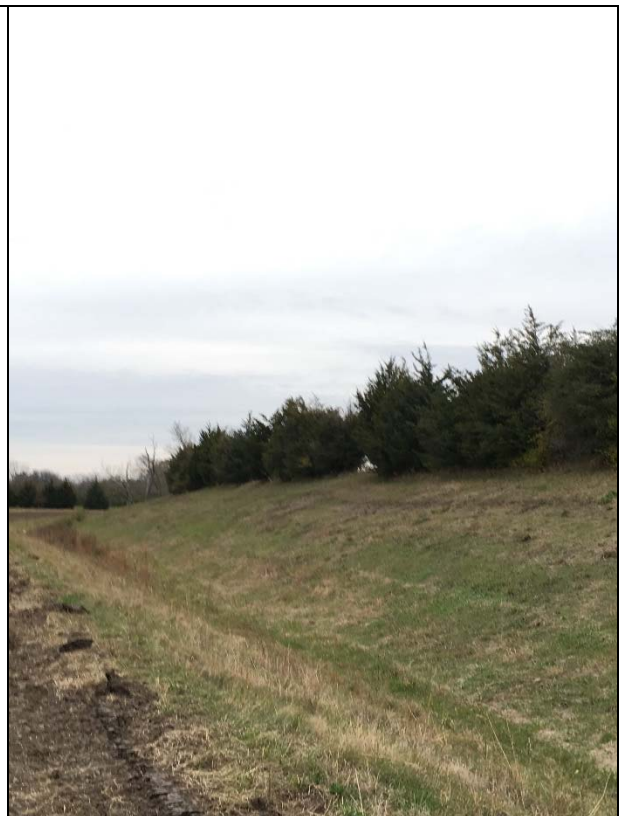
A stormwater channel is being installed along the western toe of slope of the closed Phase 2 area to promote drainage and remove ponding of water that was occurring outside of the landfill boundary. Seeding had not yet occurred at the time of the Annual Inspection. Construction was on-going and being completed in conjunction with the Phase 3 contact water management basin filling project.

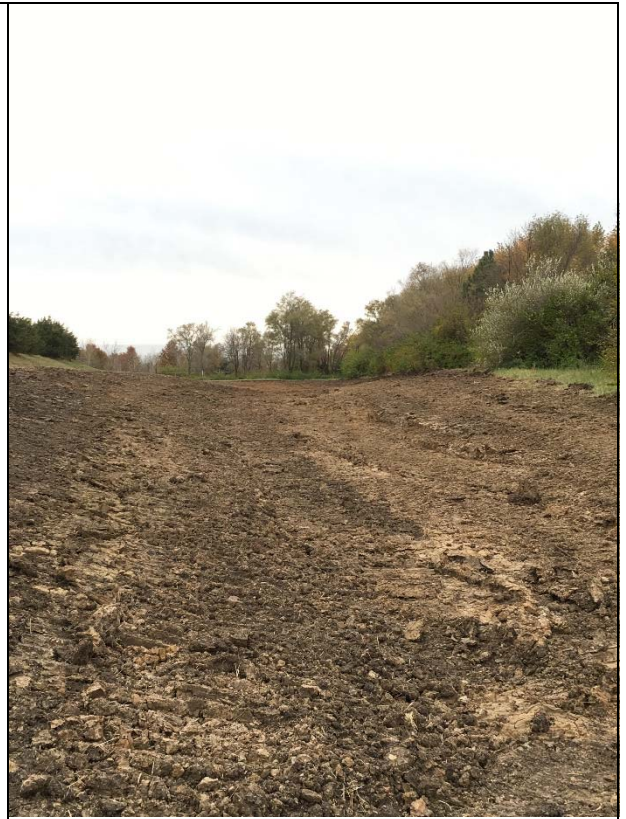
**Photograph No. 40**

The stormwater channel that is being constructed at its intersection with the perimeter road. Stormwater will enter a riprap lined section before passing through a stormwater culvert.
