**REPORT ON  
INITIAL PERIODIC STRUCTURAL STABILITY  
ASSESSMENT  
AREA 1 POND  
TECUMSEH ENERGY CENTER  
TECUMSEH, KANSAS**

By Haley & Aldrich, Inc.  
Cleveland, Ohio

For Westar Energy, Inc.  
Tecumseh, Kansas

File No. 41938-008  
September 2016

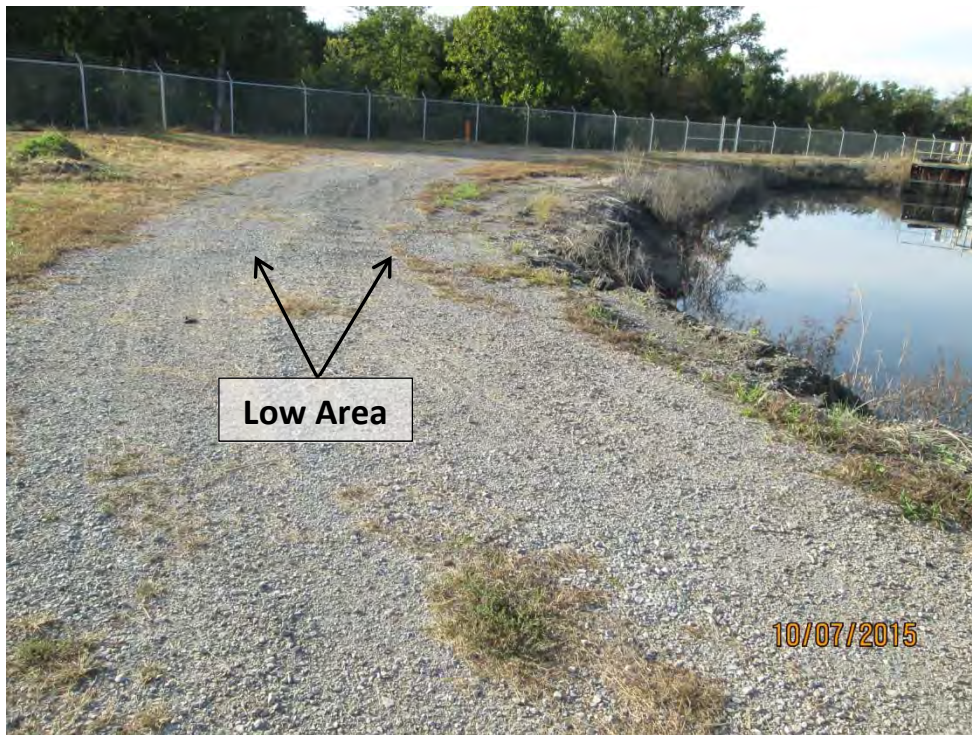
The crest alignment appeared generally level, however, a low spot exists at the southwest corner of the south pond. At this location, the crest was also sloped toward the upstream slope, resulting in some erosion of the slope caused by runoff (Photos 7 and 8).

1. A low spot exists in the berm crest at the southwest corner of the south pond. At this location, the crest is also sloped toward the upstream slope, resulting in some erosion of the upstream slope caused by runoff.

Photo No. 7  
Low Area on South Crest

1. Place and compact fill as needed to raise the grade in the low spot on the crest at the southwest corner of the south pond.
2. Backfill animal burrows with a compacted sand and gravel mix.

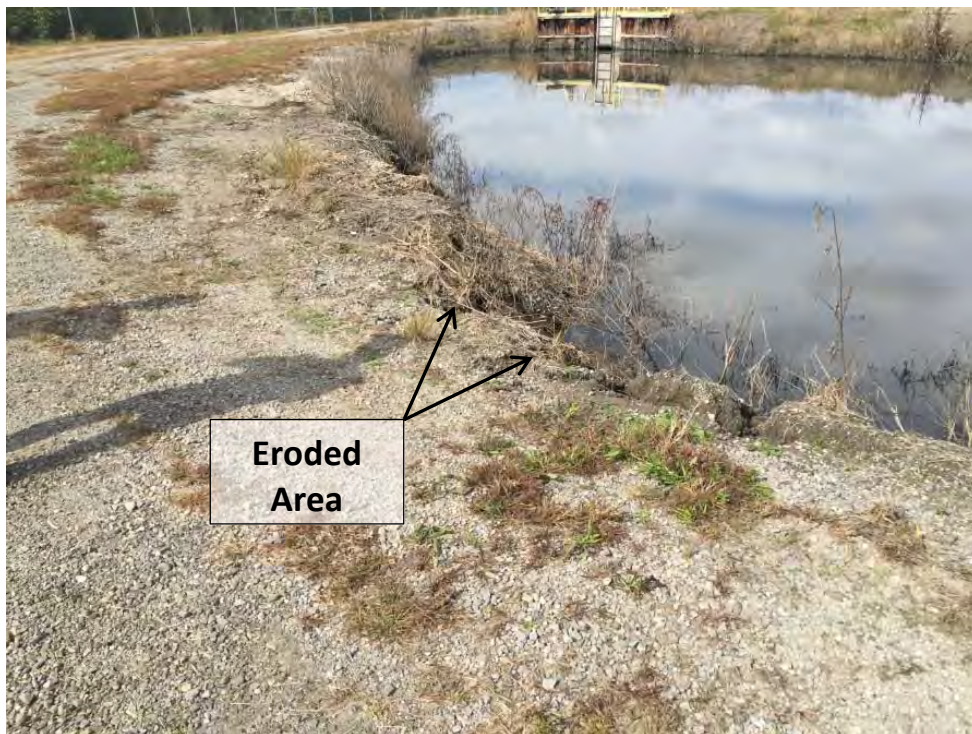
Photo No. 8  
Erosion on South Berm Upstream Slope

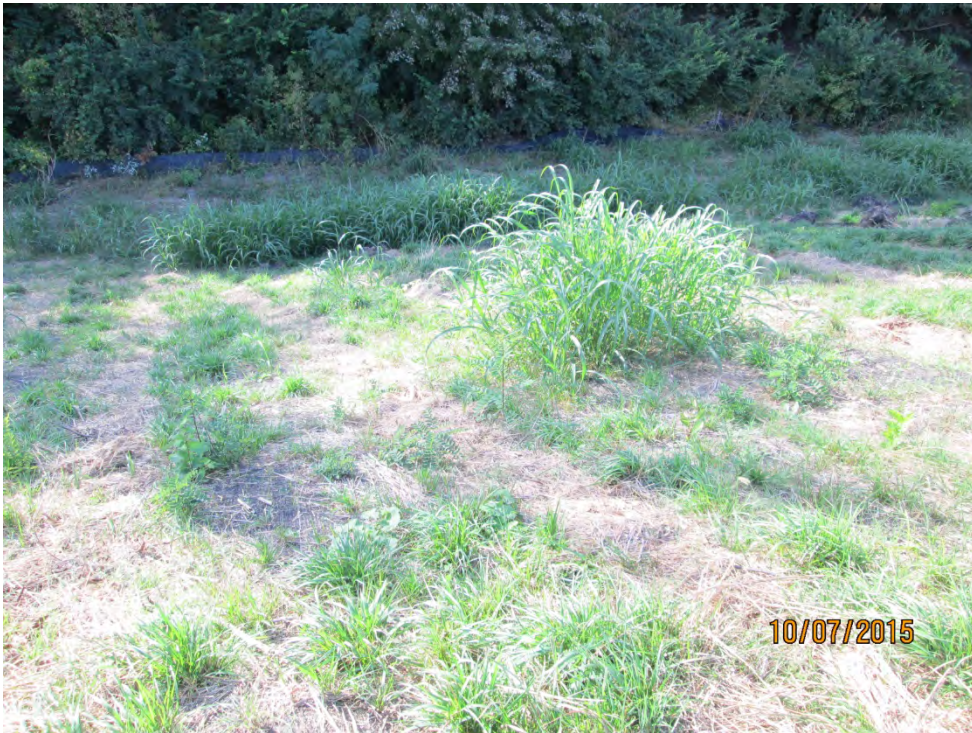
3. On the west downstream slope, grass was observed at up to 18 inches in height and patches exist where the grass is dead. On the south berm downstream slope, there are a number of patches (up to 30 ft x 30 ft in size) where the grass is dead.

Photo No. 12  
Tall Grass and Dead Vegetation on West Downstream Slope

3. Regularly manage vegetation on slopes to maintain allowable vegetative growth height.
4. Seed and re-establish vegetation in the dead patches on the south and west downstream slopes.

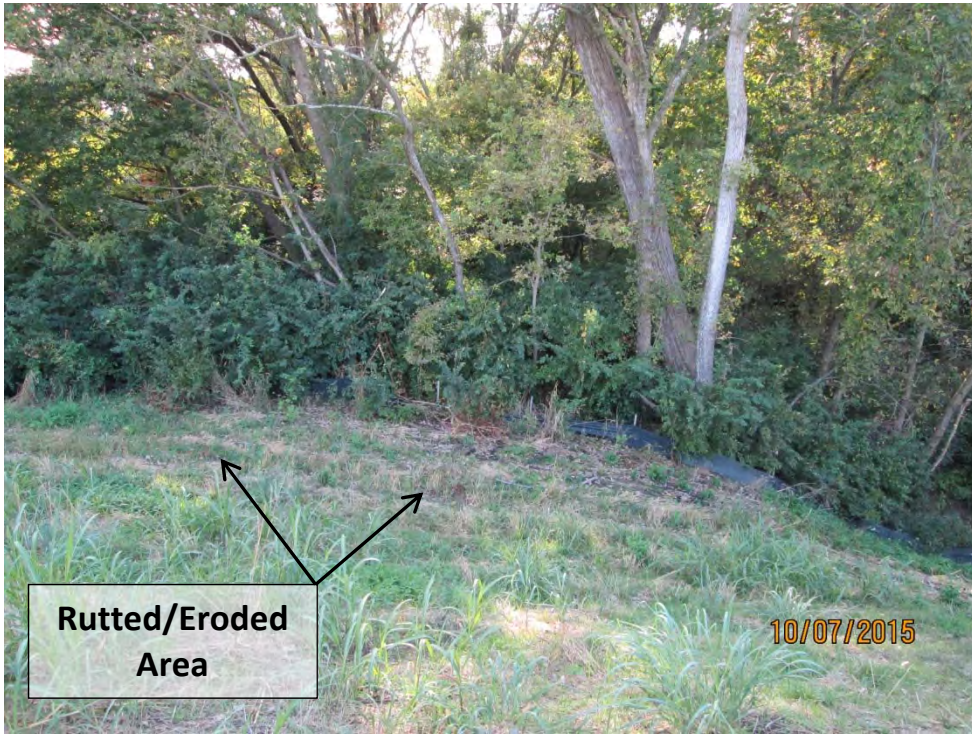
4. At the toe of the west berm, some rutting, erosion and tearing of the erosion control blanket exist where a tracked vehicle had traversed the area at some time in the past.

Erosion on the north and west downstream slopes was noted in a few limited areas. At the toe of the west berm, a tracked vehicle had traversed the area at some time in the past, causing some rutting of the soft ground and tearing of the erosion control blanket along the edge of the ruts (Photo 13). Runoff from the west slope has caused some erosion in the ruts within a relatively limited area. Some relatively minor surface erosion was also noted on the downstream slope at the junction between the west and south berms.

Photo No. 13  
Rutted/Eroded Area on West Downstream Slope

5. Fill ruts and erosion channels on the west and south downstream slopes.
6. Evaluate need for armoring the bottom of drainage ditch between SE 2<sup>nd</sup> Street and the south downstream toe of slope in the vicinity of the slough to prevent continued deepening of the channel and resulting sloughing of the downstream slope.

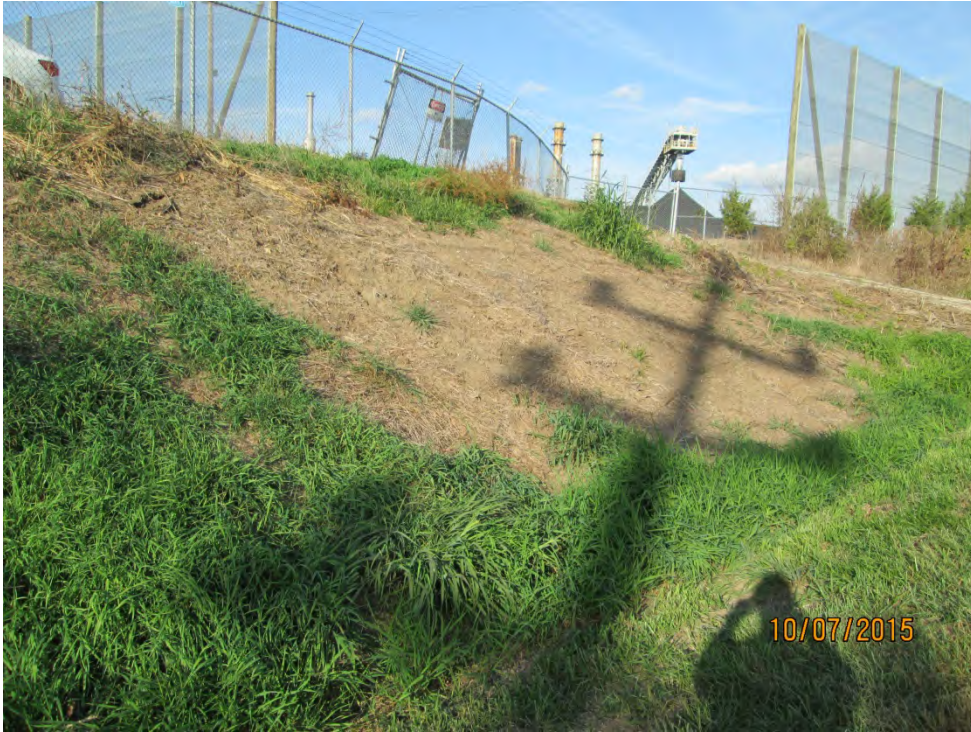
Photo No. 15  
Dead Spots on South Downstream Slope

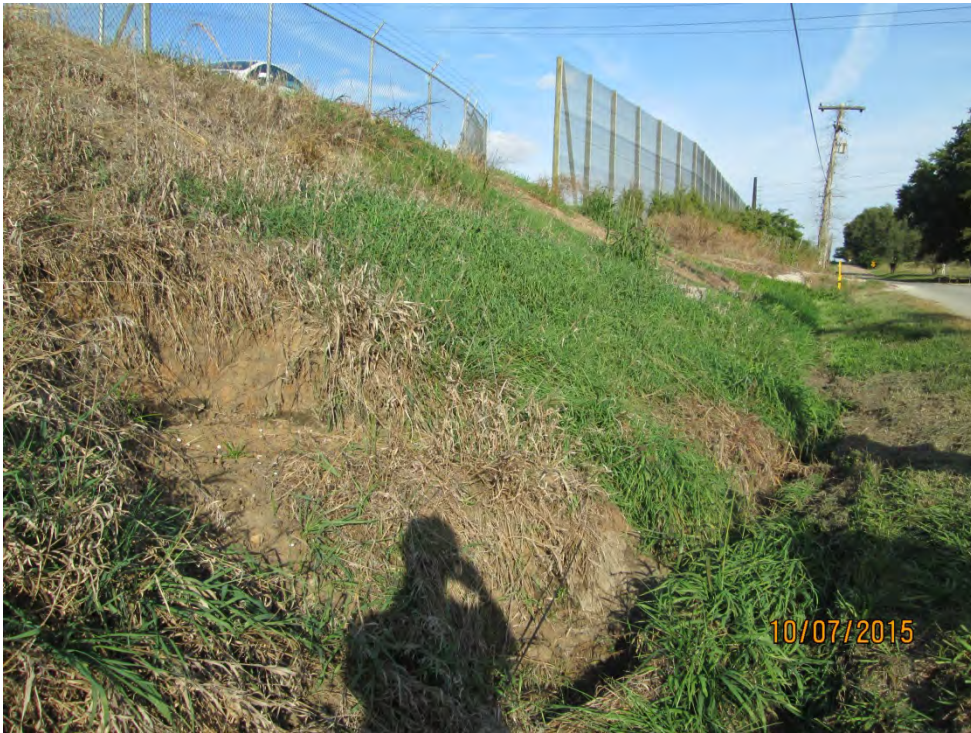
5. Some relatively minor surface erosion exists on the downstream slope at the junction between the west and south berms.
6. Localized sloughing in a 5-ft x 5-ft area of the south downstream slope caused by erosion in the bottom of the unlined drainage ditch on the north side of SE 2<sup>nd</sup> Street.

Photo No. 16  
Slough and Eroded Drainage Ditch on South Downstream Slope

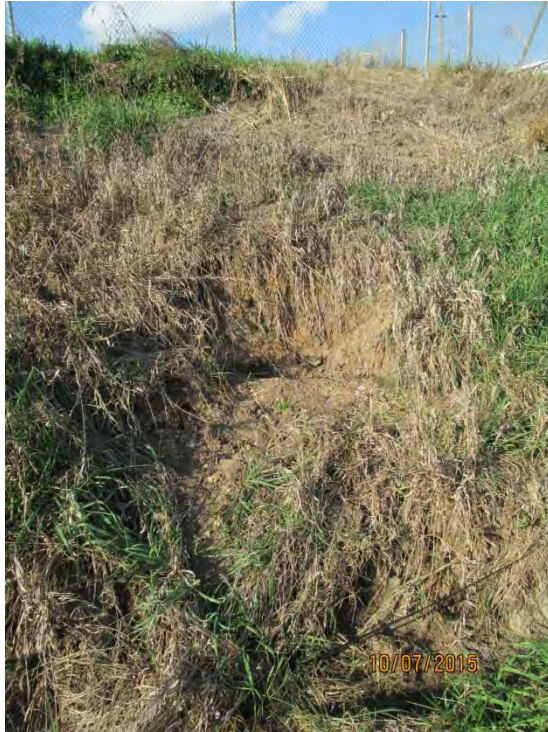
6. Localized sloughing in a 5-ft x 5-ft area of the south downstream slope caused by erosion in the bottom of the unlined drainage ditch on the north side of SE 2<sup>nd</sup> Street.

Photo No. 17  
Slough on South Downstream Slope

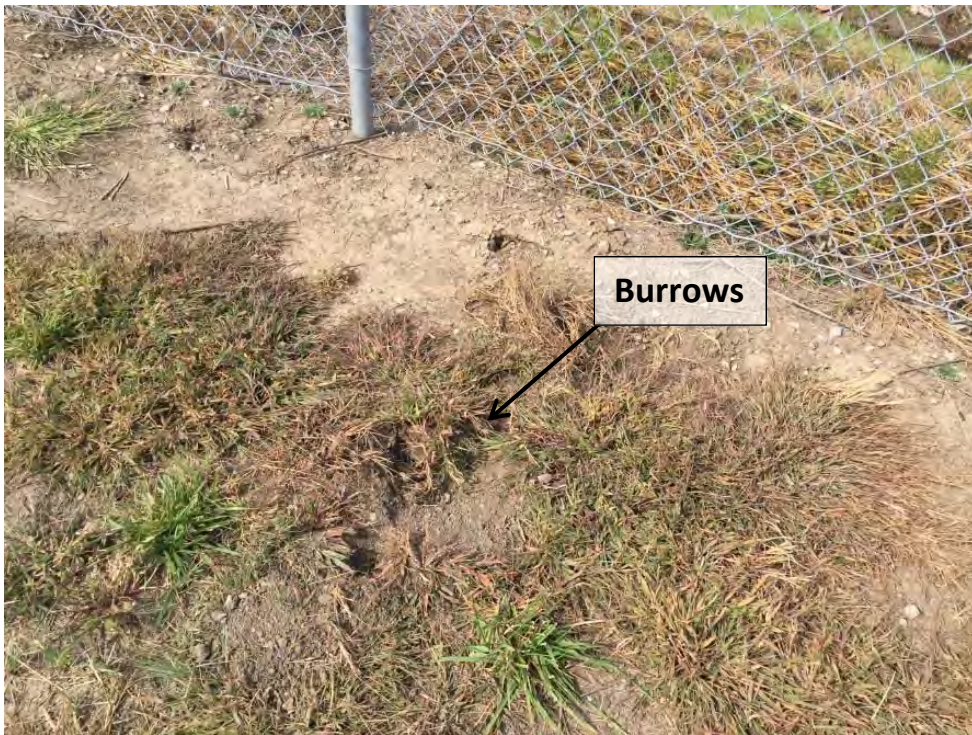
Small rodent burrows, generally about 2 inches in diameter, were noted on all downstream slopes but appeared to be most prevalent on the north slope, particularly at the top of the slope near the downstream edge of the crest (Photo 18). This may be due to the rodents being trapped under the heavy erosion control blanket on the slope, and exiting at the upper edge of the blanket at the top of the slope.

Photo No. 18  
Burrows at Top of North Downstream Slope

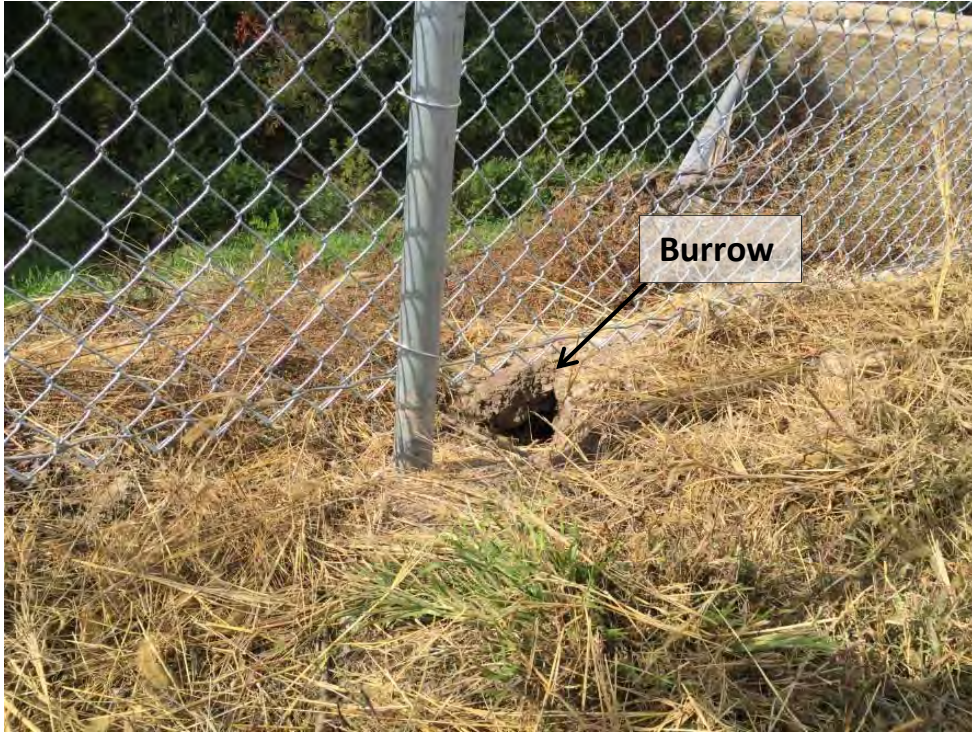
Several rodent burrows were observed along the downstream edge of the crest, primarily along the north berm at the fence line located on the downstream edge of the crest. The burrows were typically on the order of 2 inches in diameter. A somewhat larger burrow hole, approximately 3 inches in diameter, was observed at the downstream edge of the west berm crest (Photo 19). Two dead moles were observed on the crest of the west berm.

Photo No. 19  
Burrow at Downstream Edge of West Crest

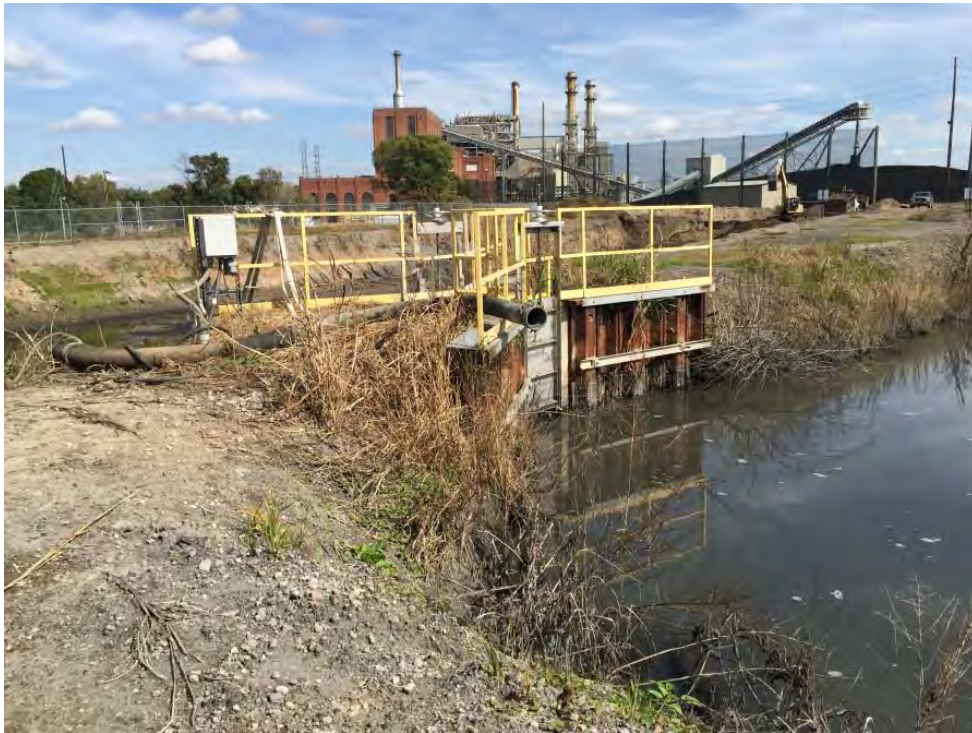
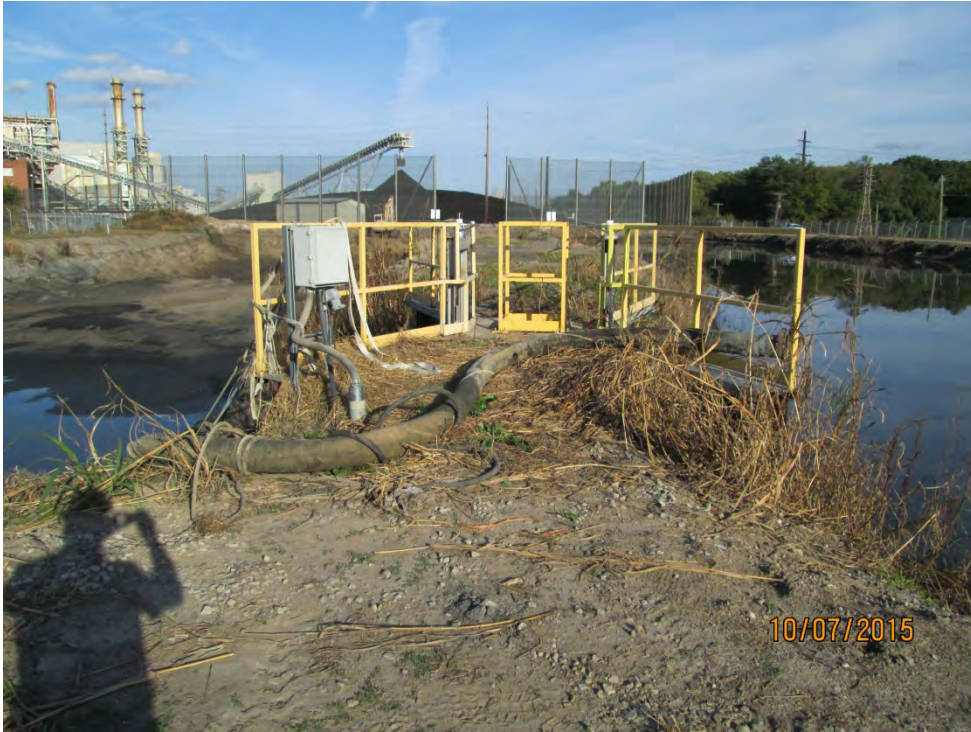
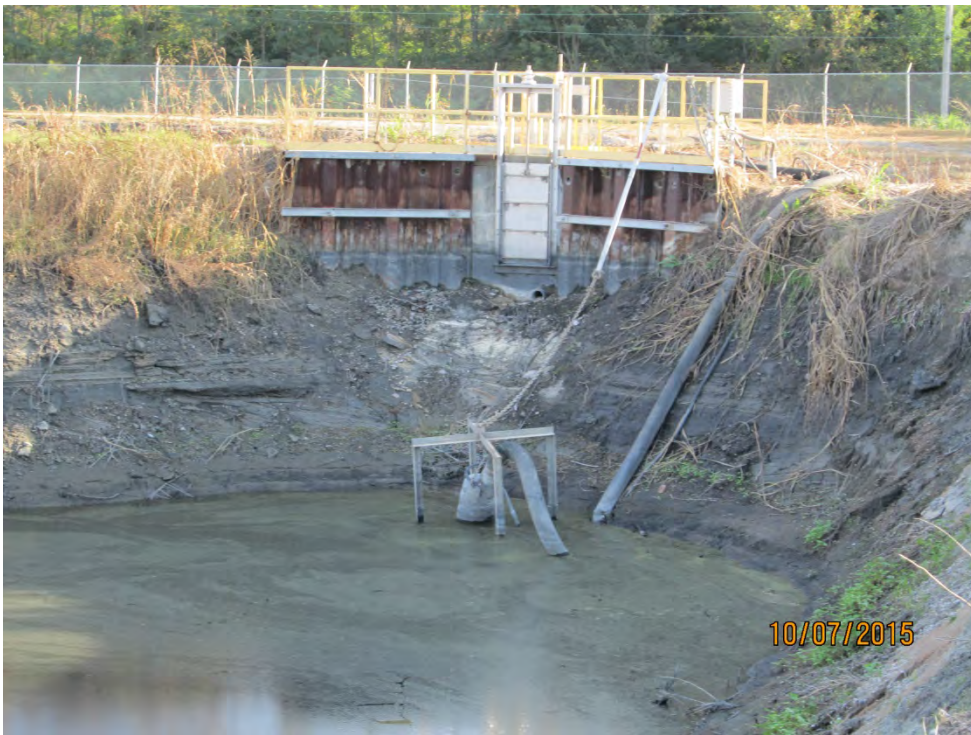
The concrete box intake structure has minor, isolated, concrete chips and weathering but was otherwise in good condition. Minor, surficial rusting was observed on the exposed metal hardware which was otherwise in good condition. After exiting the Area 1 Pond berm, the outflow pipe, which was lined with a plastic pipe insert in 2012, is above ground and the pipe and supports appeared to be in stable condition.

Photo No. 20  
Intake Structure

Photo No. 21  
Intake Structure

Photo No. 22  
Intake Structure

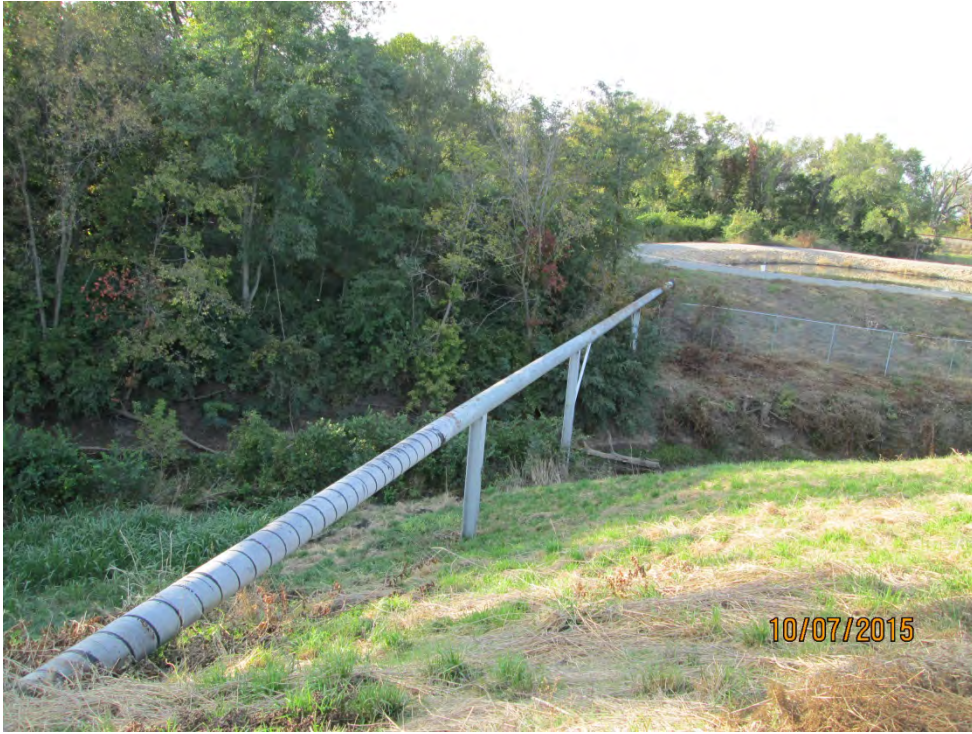
The Area 1 Pond discharges through a concrete box intake structure located at the west end of the separator berm. The concrete box intake structure discharges to a steel outflow pipe which was lined with a plastic pipe insert in 2012. The outflow pipe is buried at relatively shallow depth below the west berm before exiting the berm and running above ground to the non-CCR Area 2 Pond. There is no evidence of seepage along the outside of the outflow pipe and the above ground portion of the pipe and its supports appear to be in good condition.

Photo No. 23  
Outflow Pipe

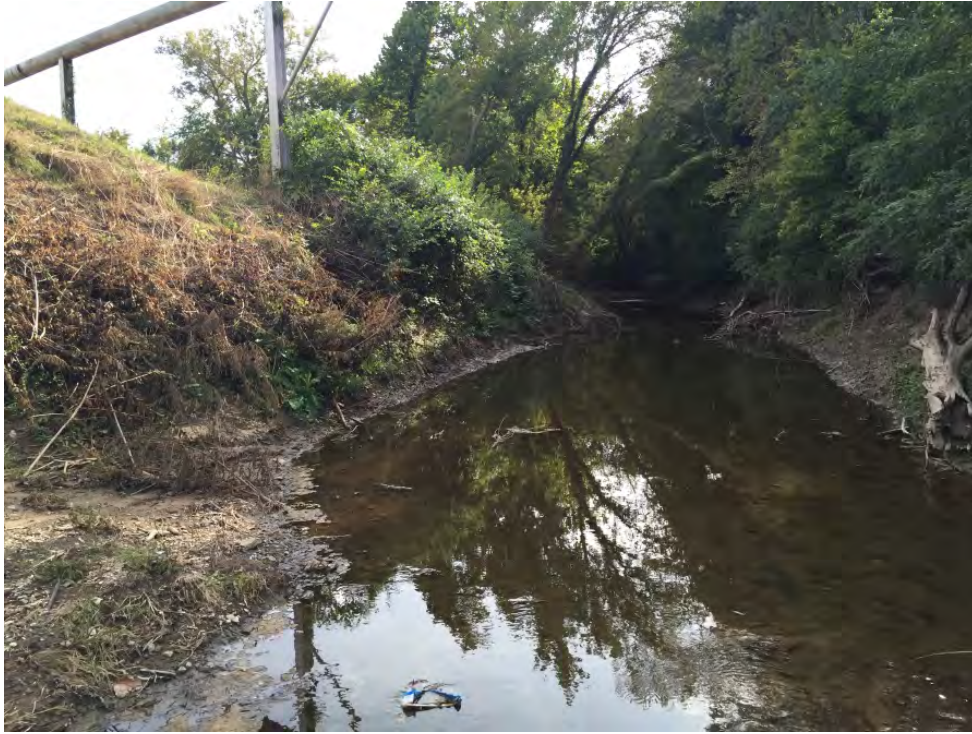
Photo No. 27  
Tecumseh Creek at Downstream Toe of Slope - Northwest Corner of Area 1 Pond

7. Regularly monitor banks of Tecumseh Creek at toe of north downstream slope for signs of instability.
8. Monitor the area of mature trees downstream of the west berm for uprooting, signs of decay, or other conditions that could potentially impact the Area 1 Pond.
