Location Restrictions Demonstration Report Bottom Ash Settling Area

Tecumseh Energy Center

Prepared for: Westar Energy
Tecumseh Energy Center
Tecumseh, Kansas

Prepared by:
APTIM Environmental & Infrastructure, Inc.

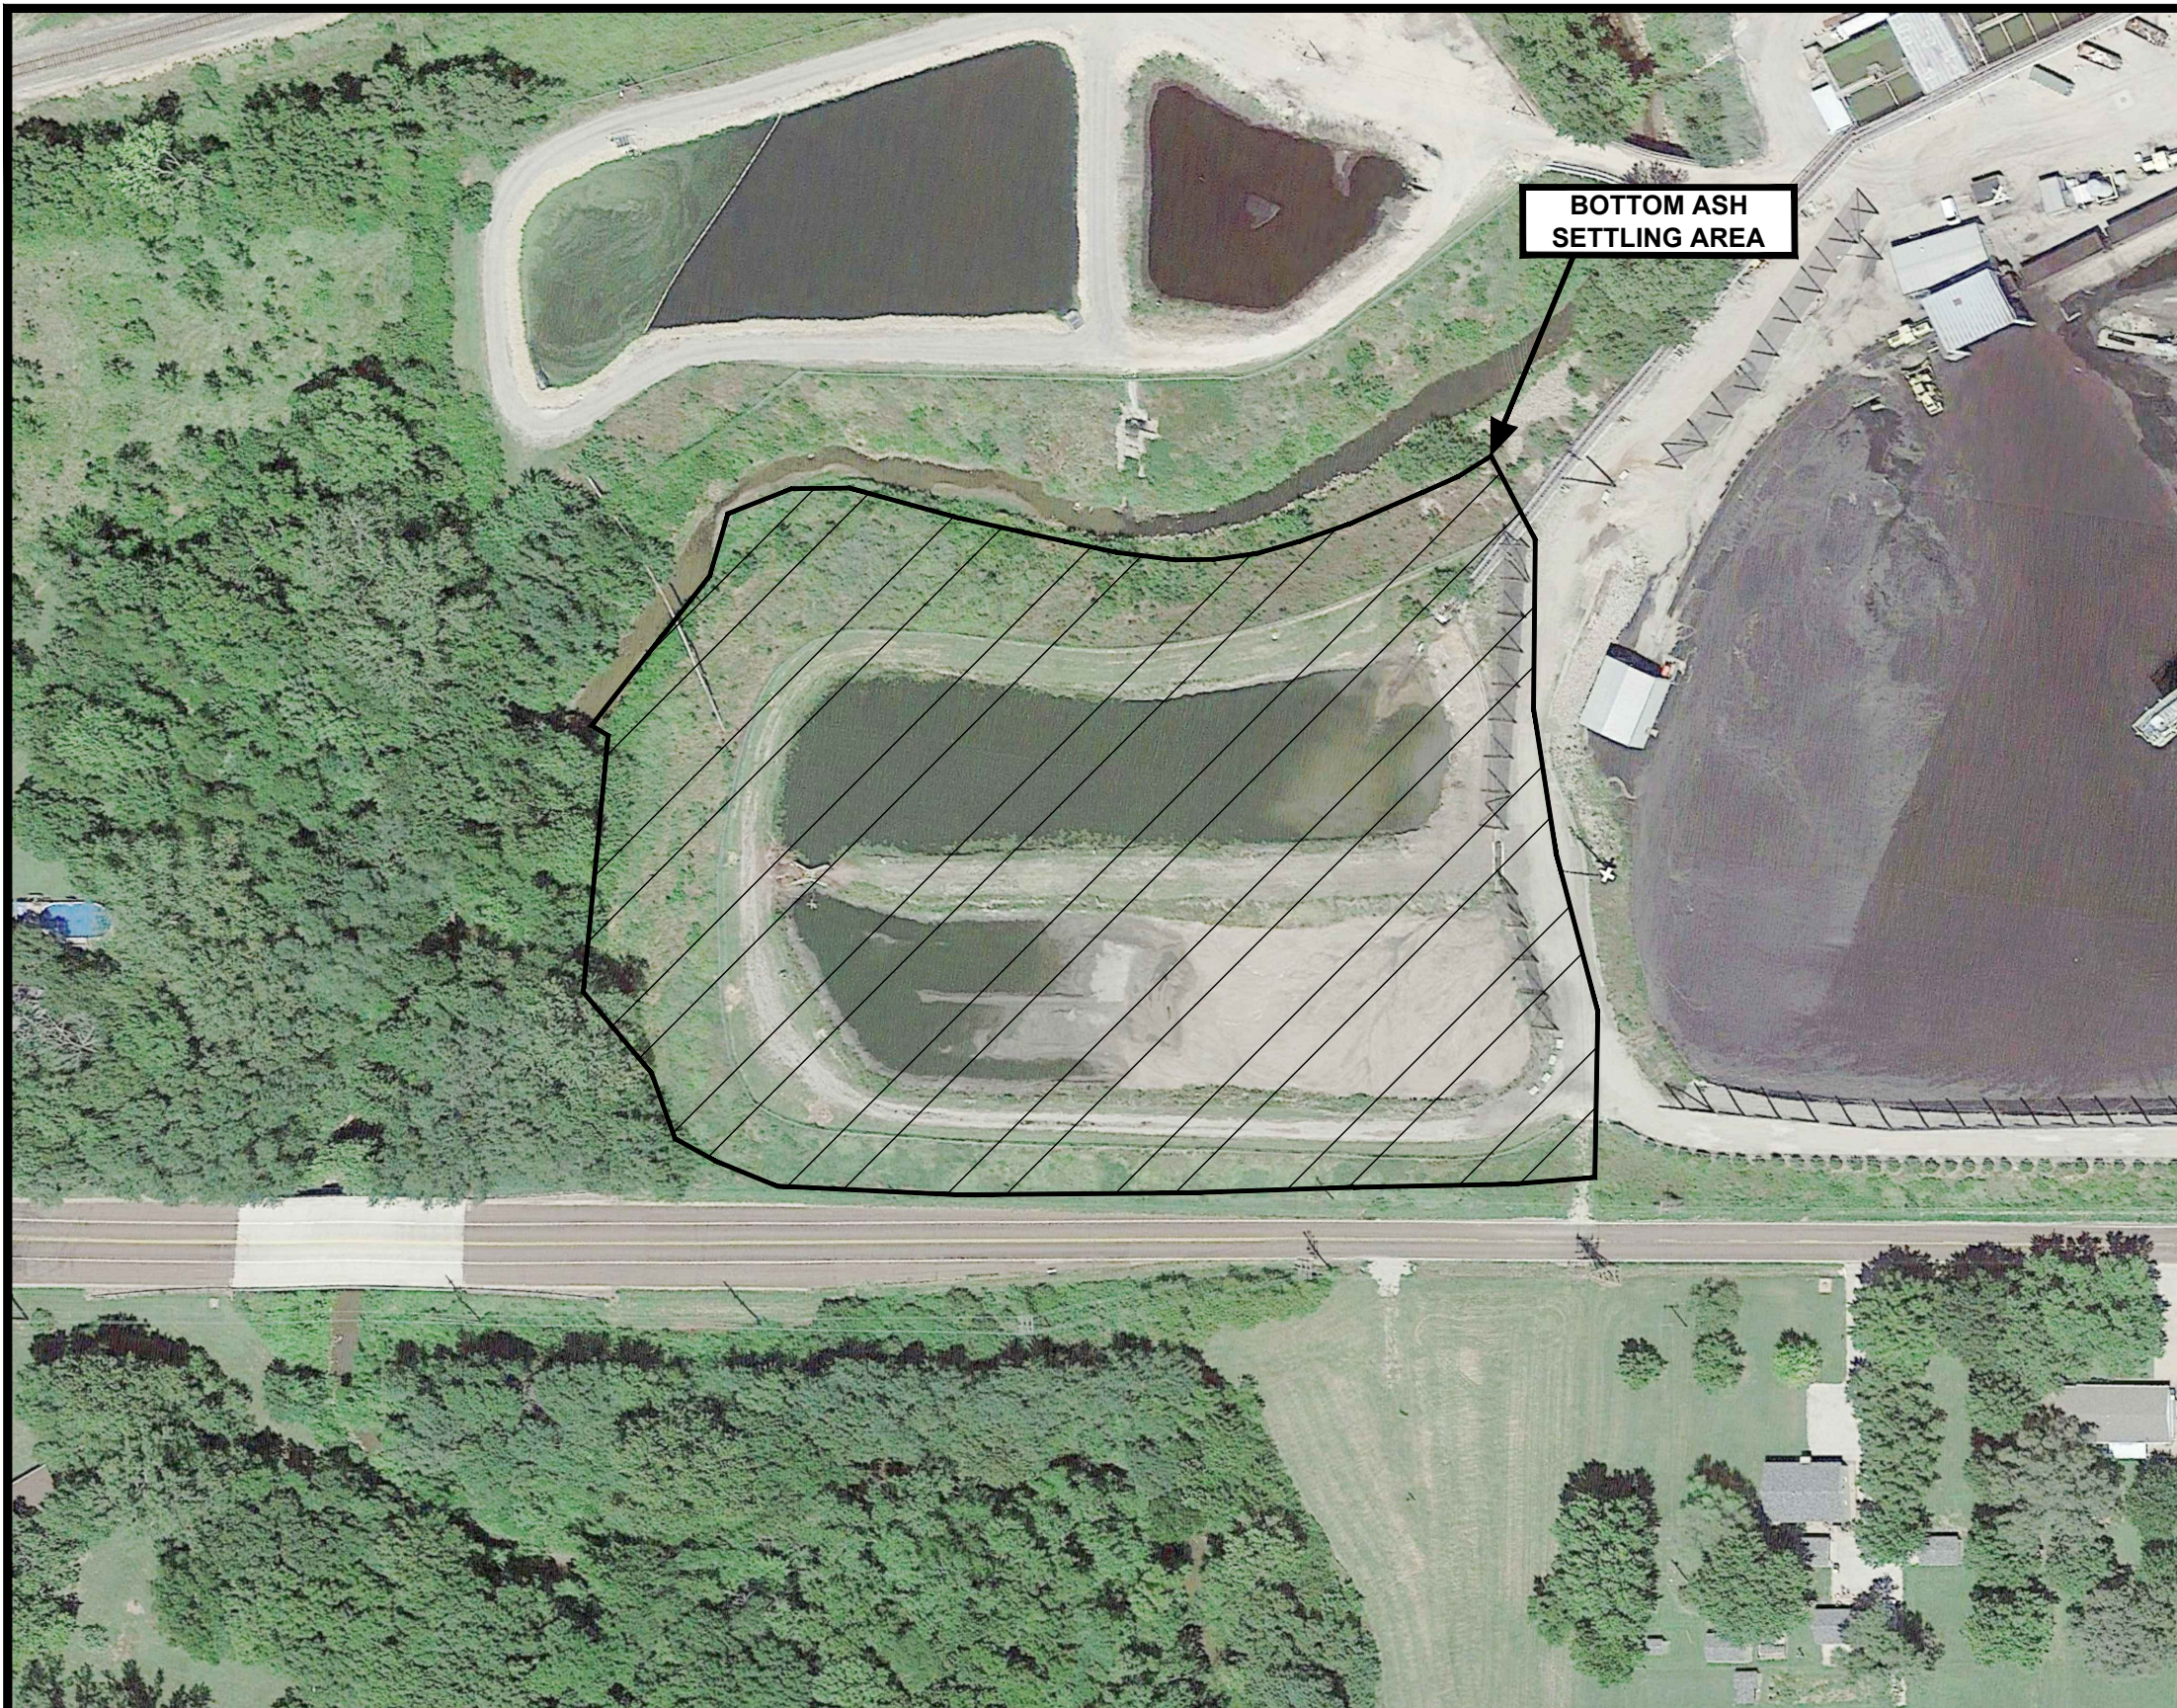
FIGURE 2
MAP OF WETLANDS INSPECTION AREA

A Certified Wetland Delineator visited the Unit on August 22, 2018 to determine if any area within the boundary of the Unit is potentially located in an existing wetland area, as defined in 40 CFR §232.2. Details of the area inspected are presented in **Figure 2**. Based on the conclusions during the site visit and wetland inspection, APTIM determined that the Unit is not located within an existing wetland area. Consequently, no additional demonstration is necessary.

AREAS FOUND NOT TO INCLUDE WETLANDS BASED ON INSPECTION
