# Annual Inspection Report Tecumseh Energy Center Industrial Landfill #0322

Prepared for:  
Westar Energy  
Tecumseh Energy Center  
Tecumseh, Kansas

Prepared by:  
APTIM Environmental & Infrastructure, Inc.

January 2018

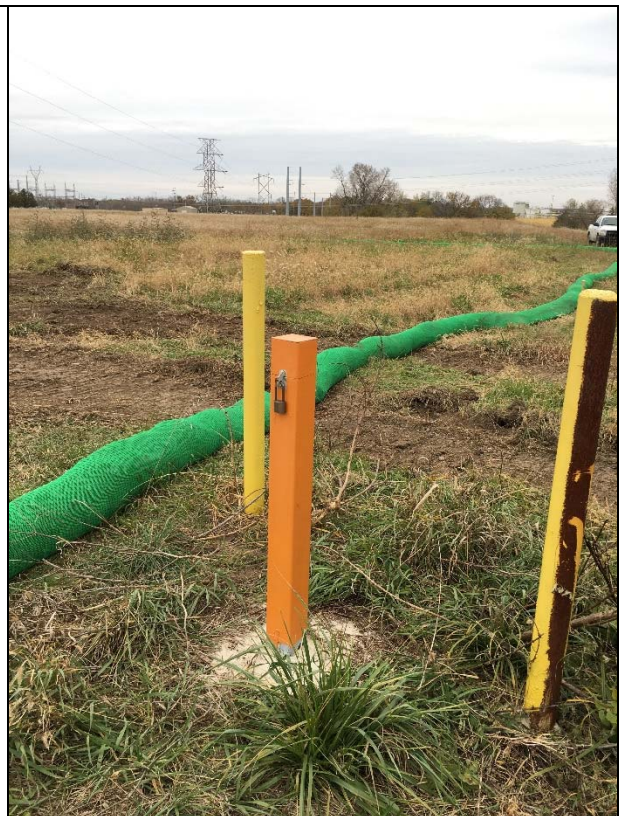
Observing the vegetated cover at Phases 1 and the undisturbed areas of Phase 3 (outside of construction area). Vegetation is well established and maintained. No evidence erosion, ponding, or animal burrows. No stability concerns.

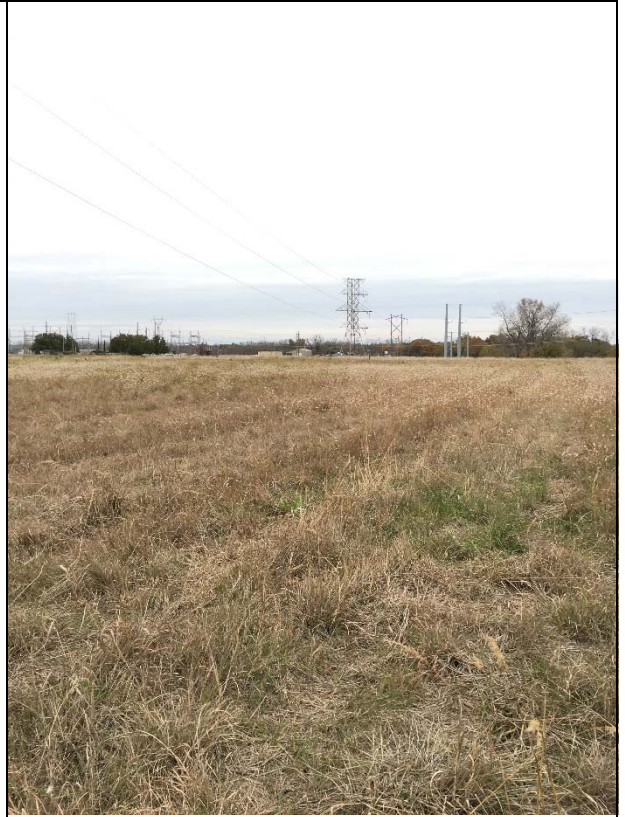
**Photograph No. 18**

Phase 3 construction area where former contact water management basin has been filled to surrounding grade. No signs of ponding water. Seeding has not yet occurred (construction was ongoing at the time of inspection).

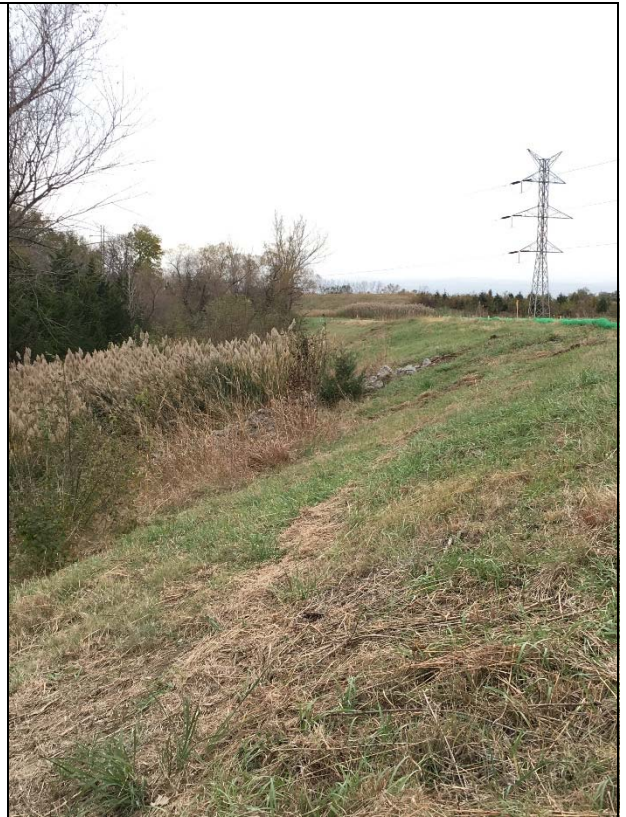
**Photograph No. 22**

Vegetation is well established and maintained. No evidence of stability concerns or erosion.

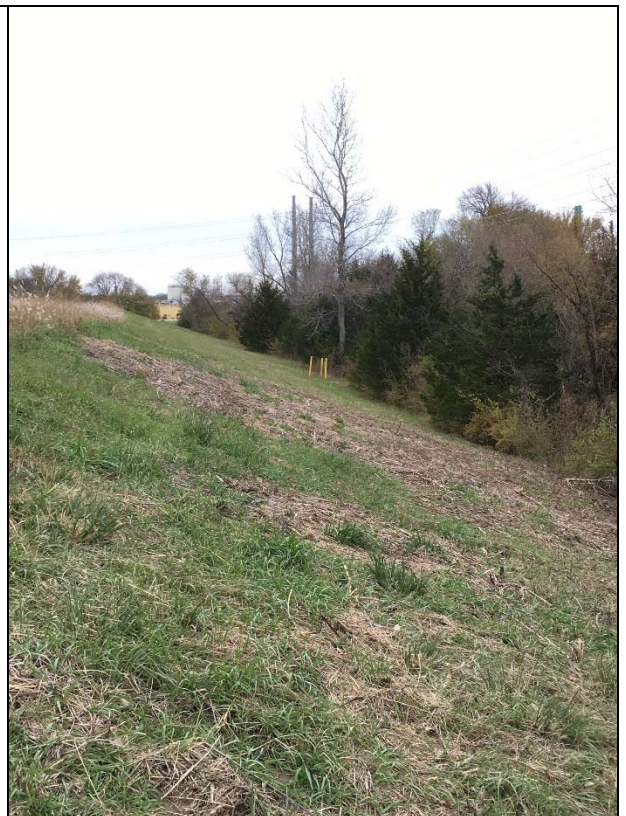
Vegetation on sideslope.

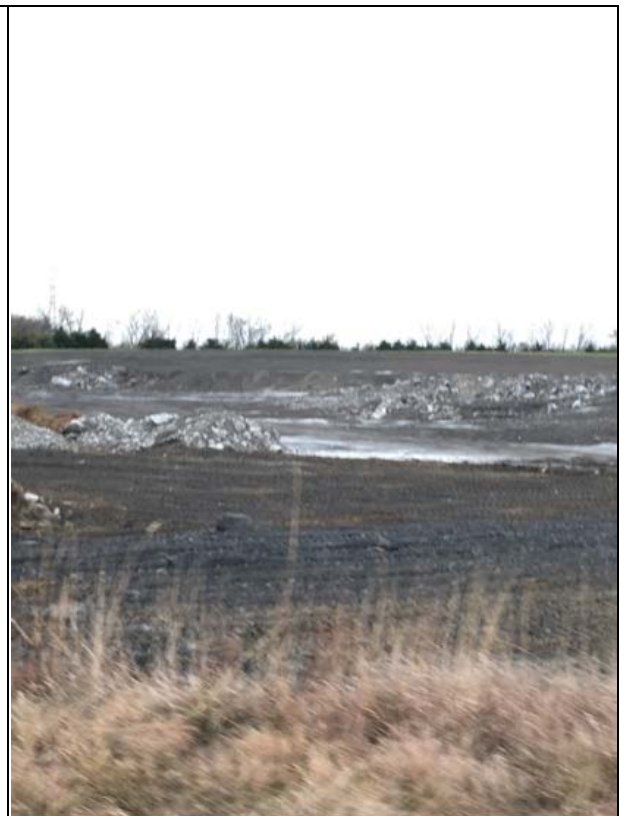
Active face of Phase 2. The active face is well maintained. CCR material is being spread by a dozer. No fugitive dust observed to be generated as part of operations.

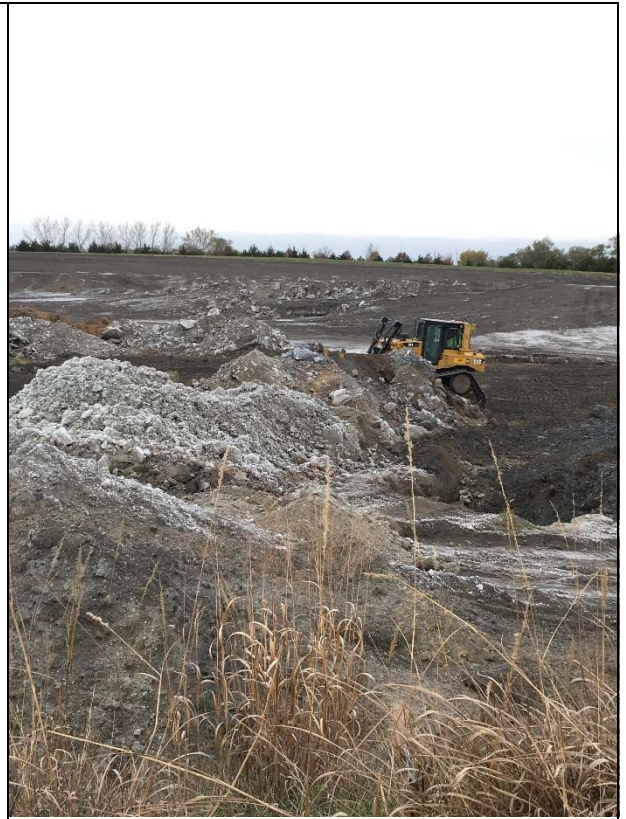
**Photograph No. 26**

Active face of Phase 2. The active face is well maintained. No fugitive dust observed to be generated as part of operations.

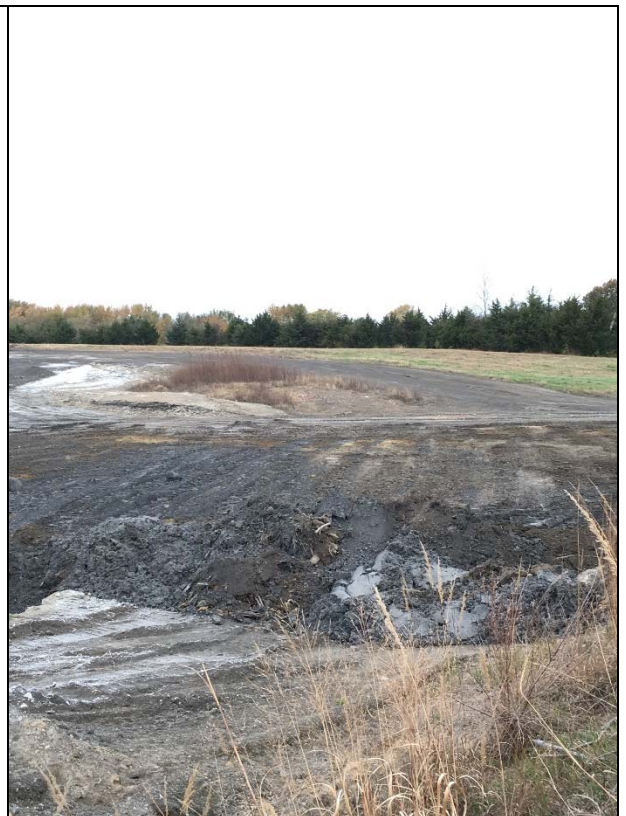
Overview of Phase 3 construction area where the contact water management basin has been removed by placement of fill to surrounding grade. The overview shows the uniformity in fill placement and the complete removal of standing water.

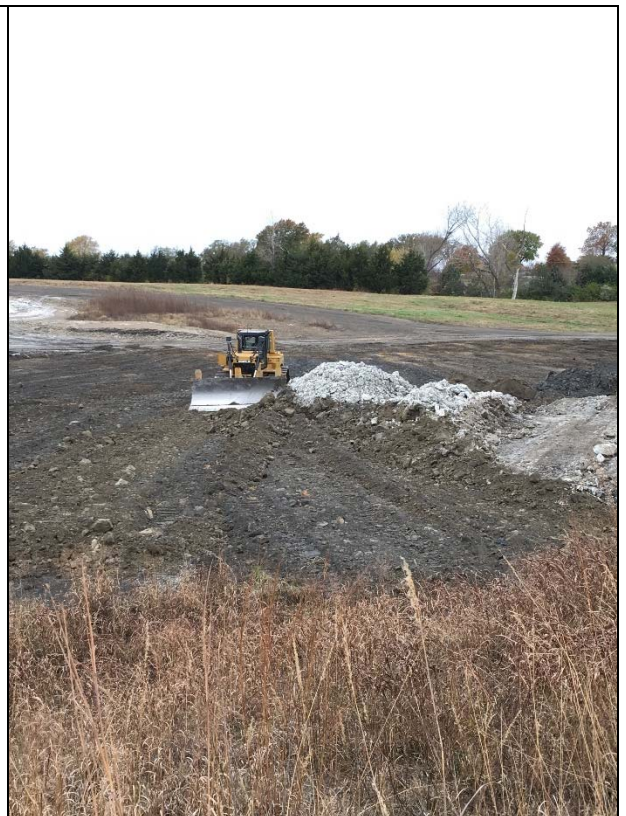
Active face of Phase 2. The active face is well maintained. No fugitive dust observed to be generated as part of operations.

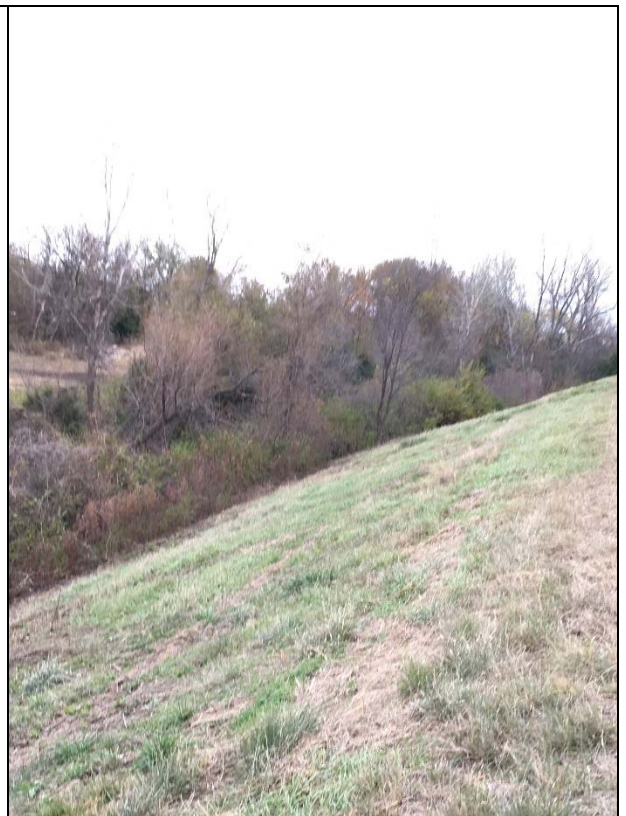
Observing the certified closed area of Phase 2. Vegetation is well established and maintained. No evidence of ponding, erosion, animal burrows, or stability concerns.

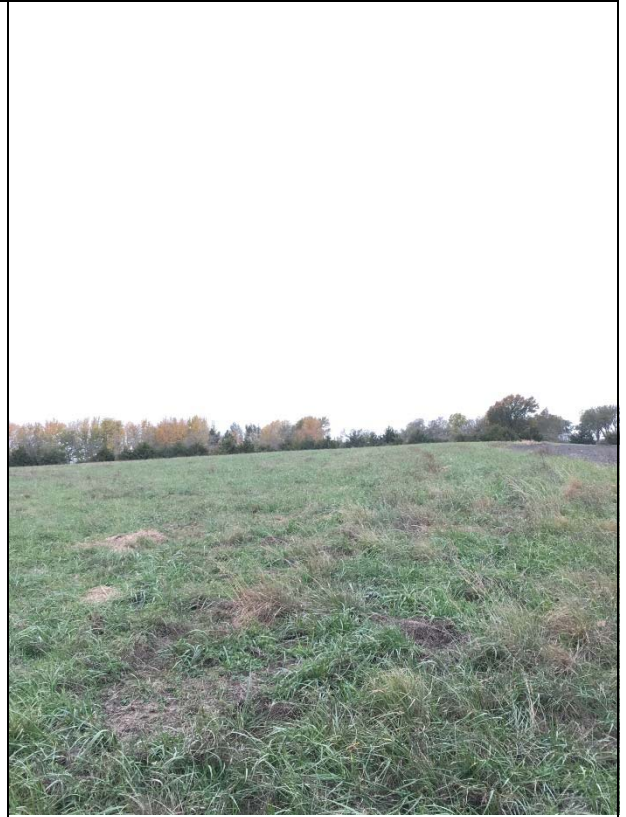
**Photograph No. 34**

Observing the certified closed area of Phase 2. Vegetation is well established and maintained. No evidence of ponding, erosion, animal burrows, or stability concerns.

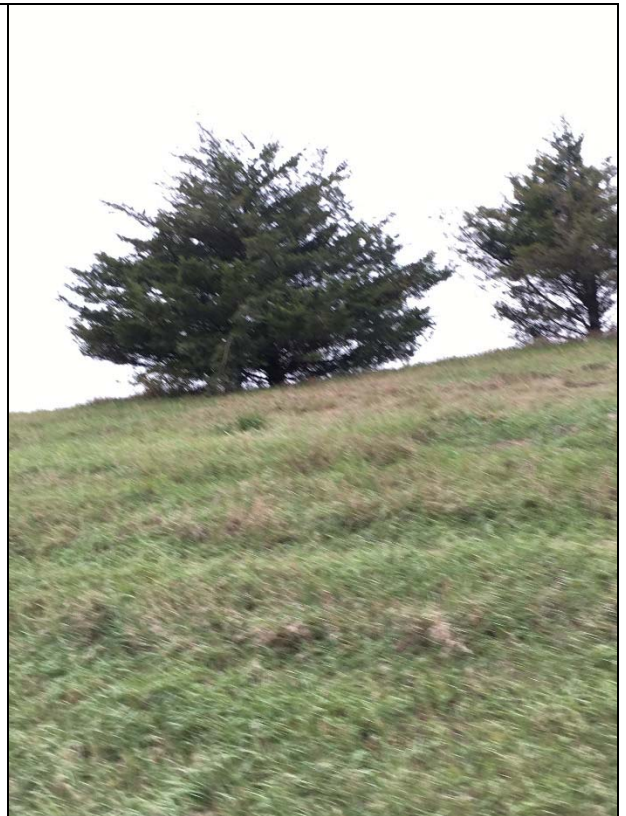
Observing the certified closed area of Phase 2. Vegetation is well established and maintained. No evidence of ponding, erosion, animal burrows, or stability concerns.

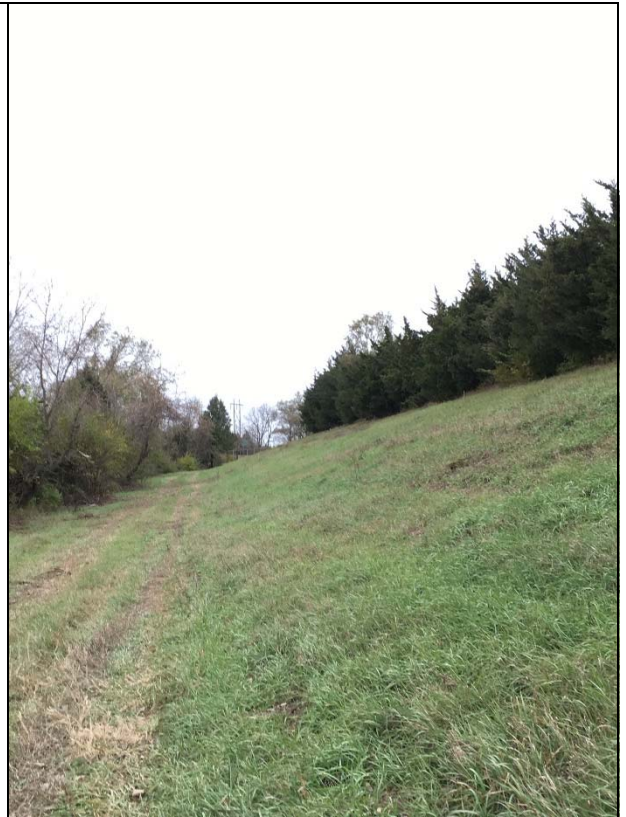
**Photograph No. 36**

Observing the certified closed area of Phase 2. Vegetation is well established and maintained. No evidence of ponding, erosion, animal burrows, or stability concerns.

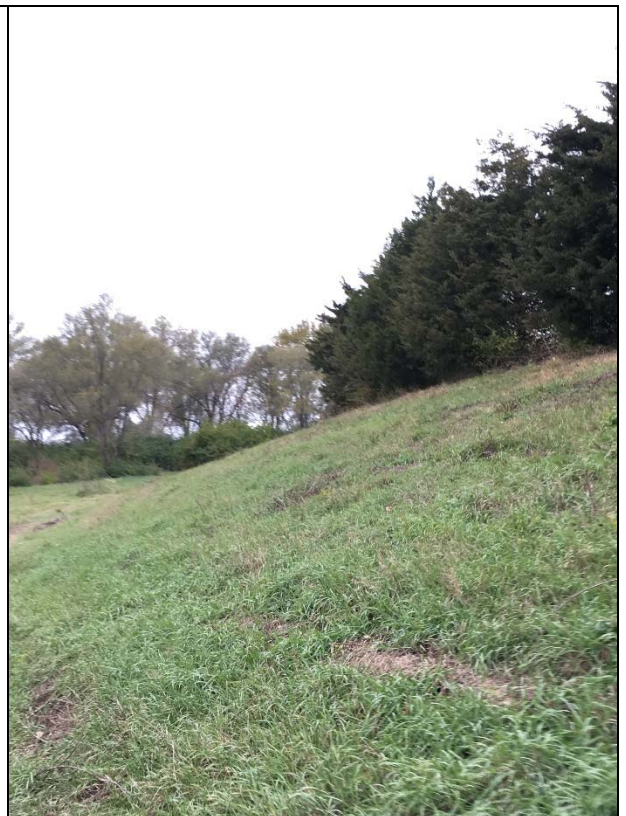
Observing the upgradient monitoring well.

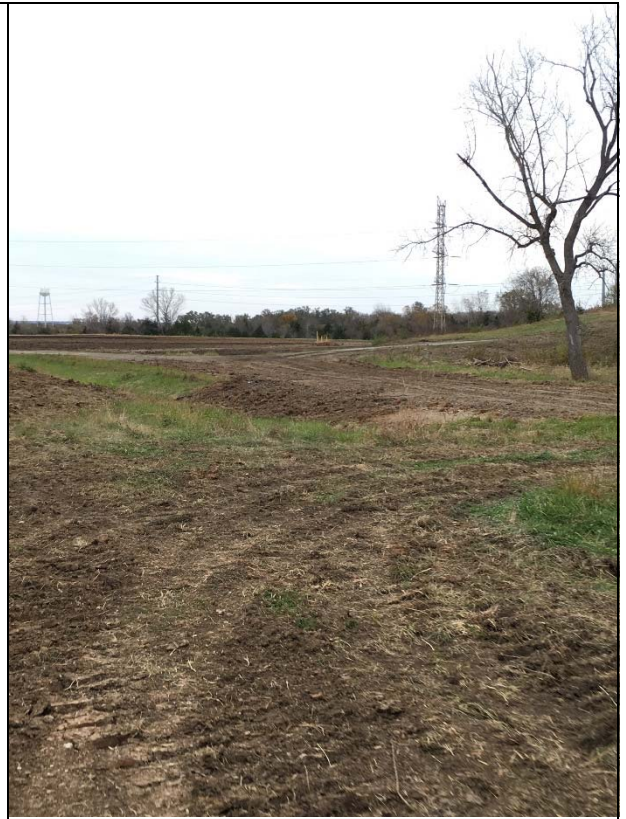
**Photograph No. 42**

Phase 3 construction area where former contact water management basin has been filled to surrounding grade. No signs of ponding water. Seeding has not yet occurred (construction was ongoing at the time of inspection).
