**REPORT ON  
INITIAL PERIODIC STRUCTURAL STABILITY  
ASSESSMENT  
AREA 1 POND  
TECUMSEH ENERGY CENTER  
TECUMSEH, KANSAS**

By Haley & Aldrich, Inc.  
Cleveland, Ohio

For Westar Energy, Inc.  
Tecumseh, Kansas

File No. 41938-008  
September 2016

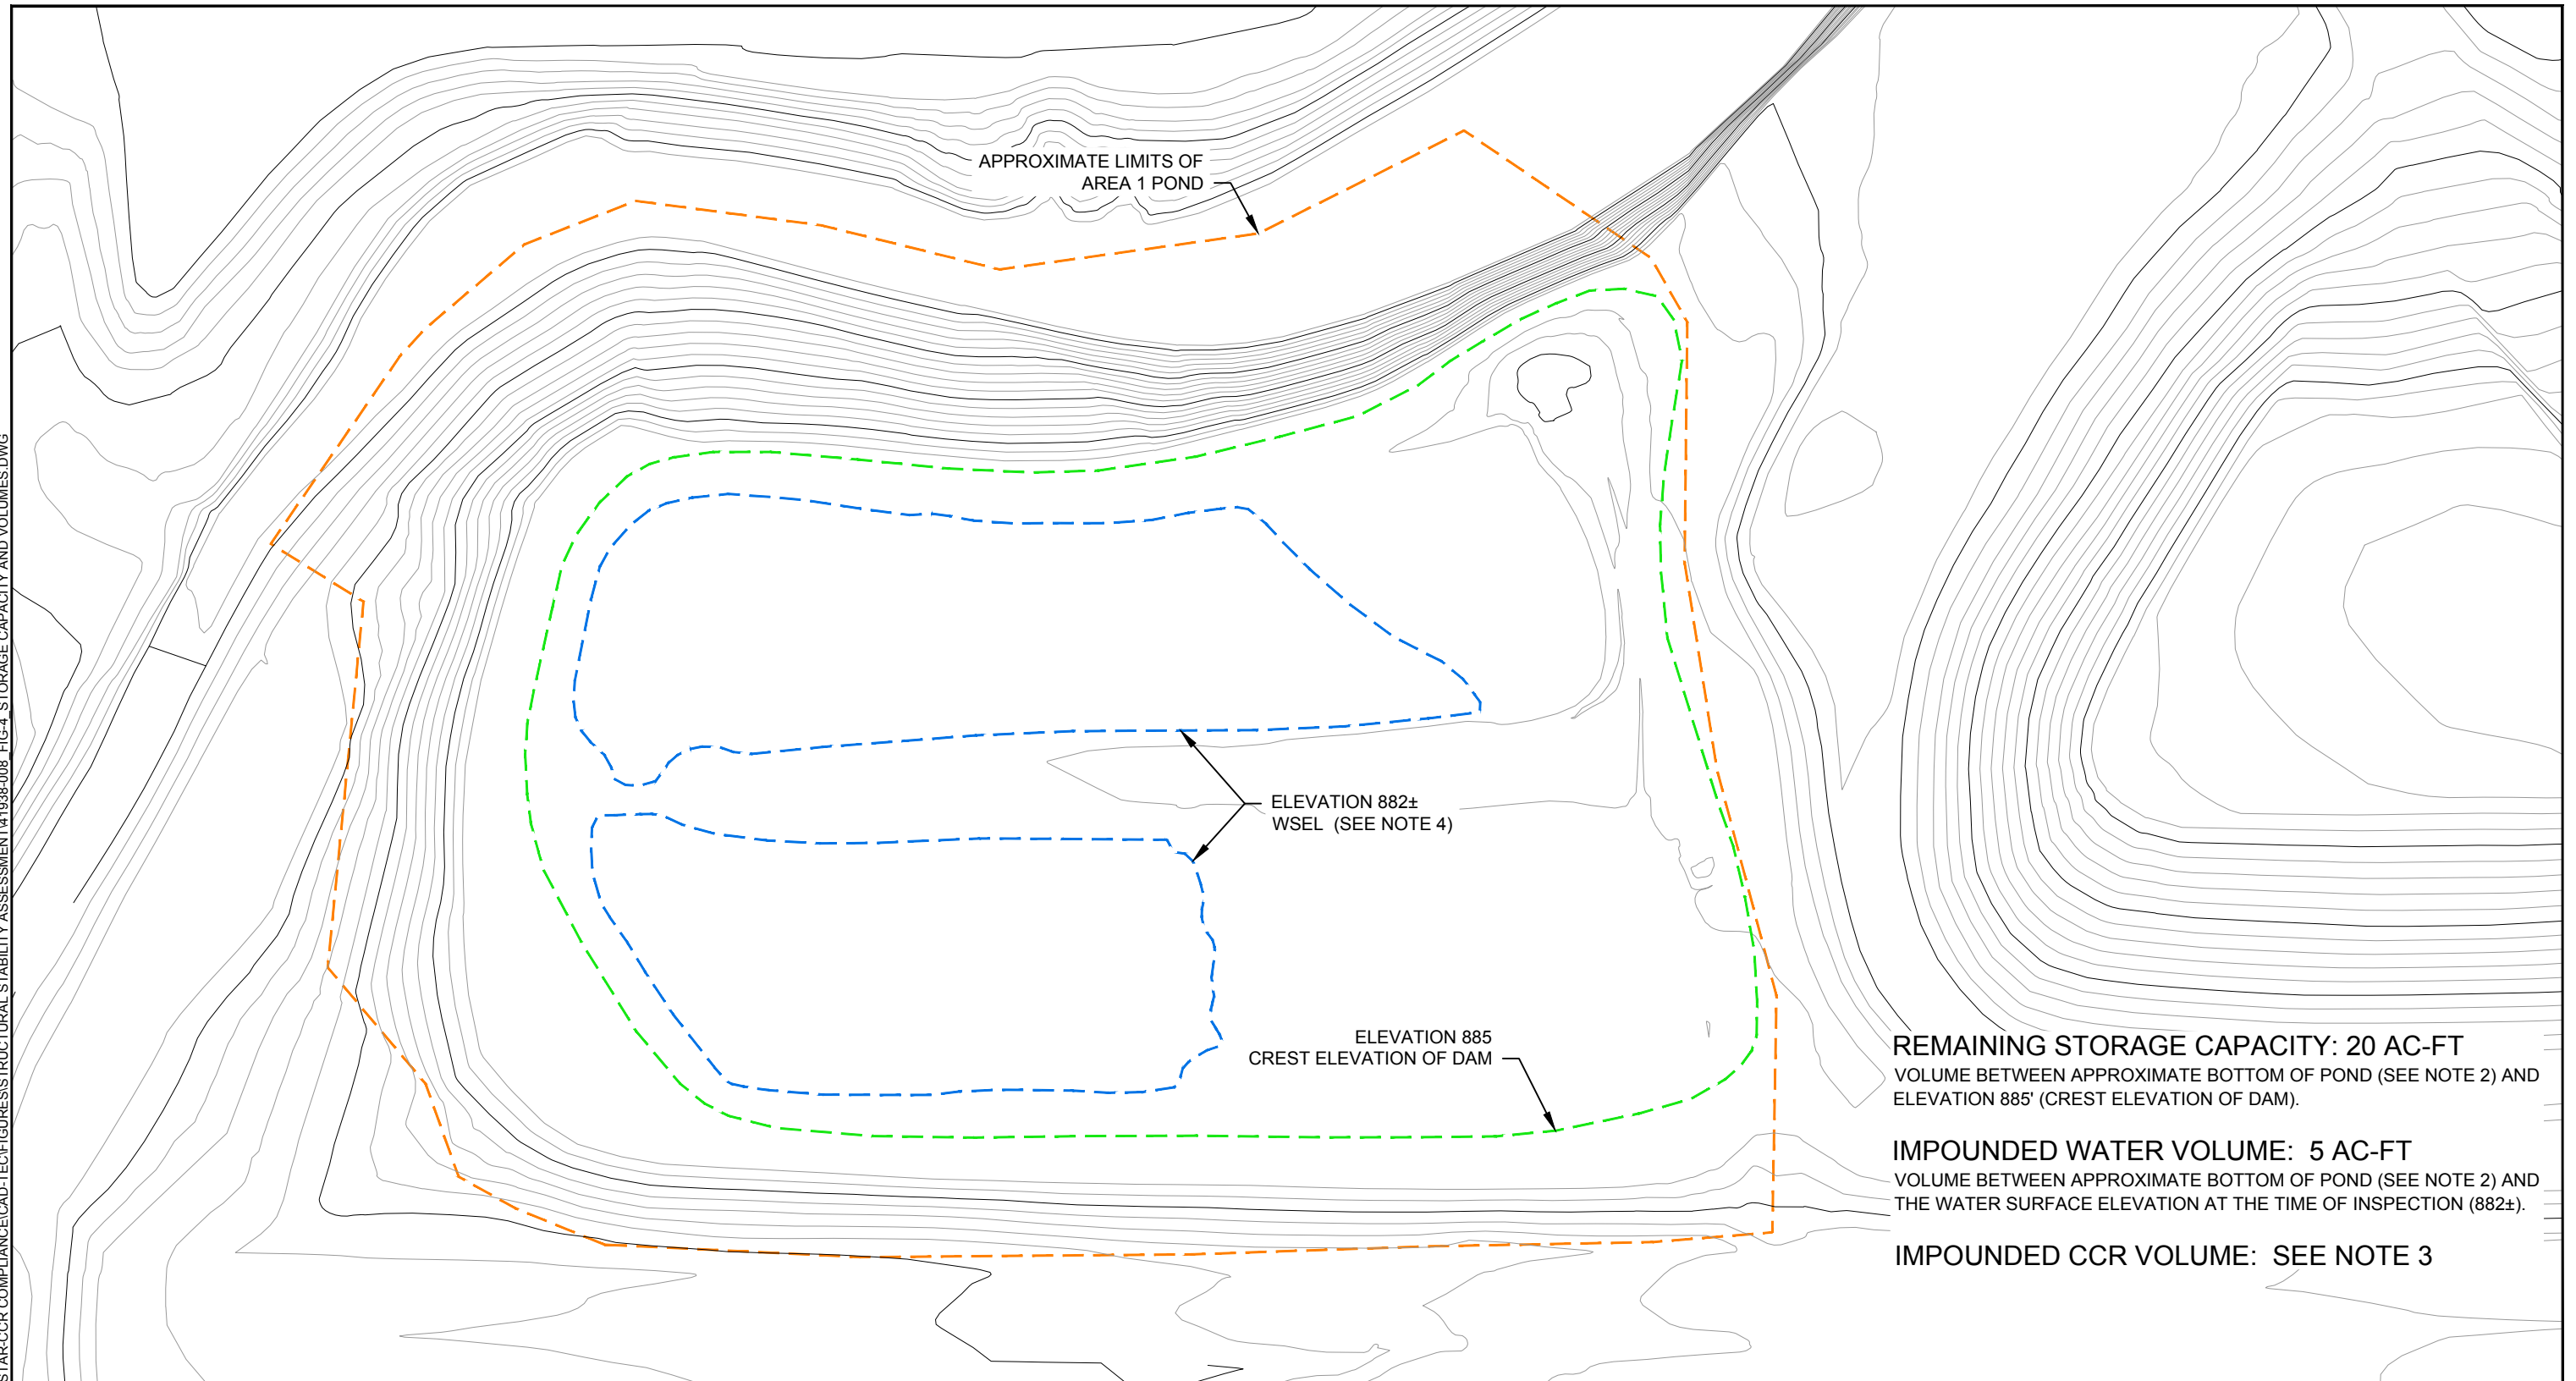
**FIGURE 4**

The design total capacity of the impoundment is approximately 20 acre-ft as estimated from the most recent topographic survey. As described in Figure 4, the remaining storage capacity was approximated by determining the volume of the impoundment (as of the most recent survey Western Air Maps and PEC) below El. 885, which is the elevation of the berm crest on the inspection date. Because no bathymetric data was available, the bottom of the pond was approximated to be at El. 877.

**REMAINING STORAGE CAPACITY: 20 AC-FT**  
VOLUME BETWEEN APPROXIMATE BOTTOM OF POND (SEE NOTE 2) AND ELEVATION 885' (CREST ELEVATION OF DAM).

**IMPOUNDED WATER VOLUME: 5 AC-FT**  
VOLUME BETWEEN APPROXIMATE BOTTOM OF POND (SEE NOTE 2) AND THE WATER SURFACE ELEVATION AT THE TIME OF INSPECTION (882±).

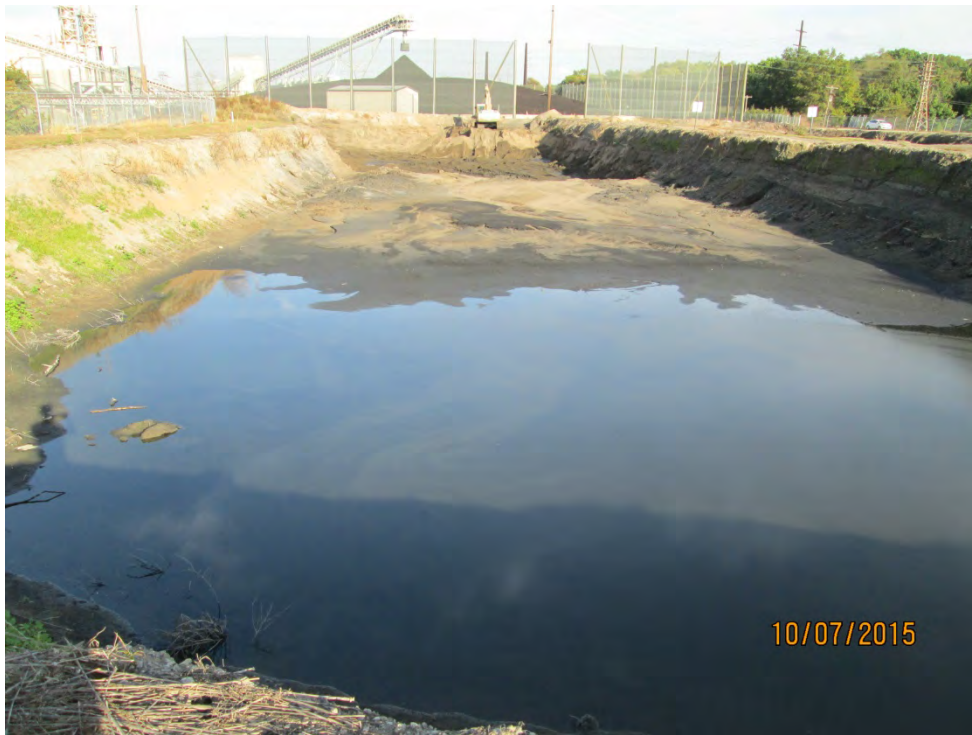
Photo No. 2  
North Pond

At the time of the inspection, the north pond had been drained and the full height of the slope was visible. The south pond was filled with water with approximately 3 ft of the slope visible above the water surface (pond level at approximately El. 882). See Photos 1 through 4.

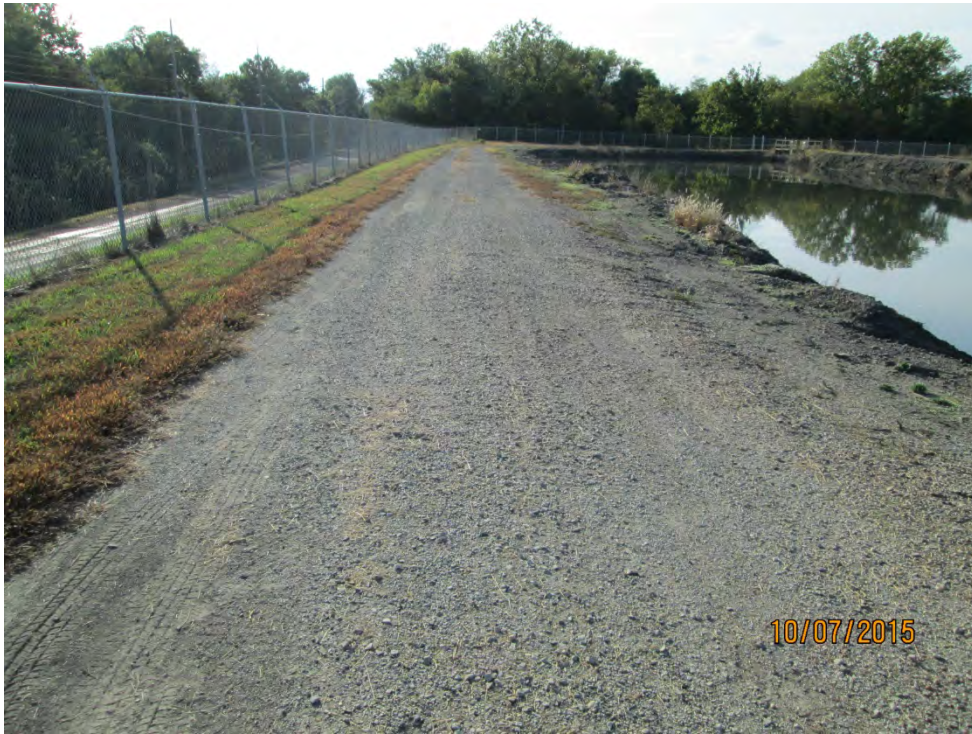
Photo No. 5  
South Berm Crest

The berm crests are generally 18 to 25 ft in width and are gravel surfaced, providing access to service vehicles around the ponds. The surface is hard and being capable of supporting vehicle traffic without significant rutting (Photos 5 and 6).

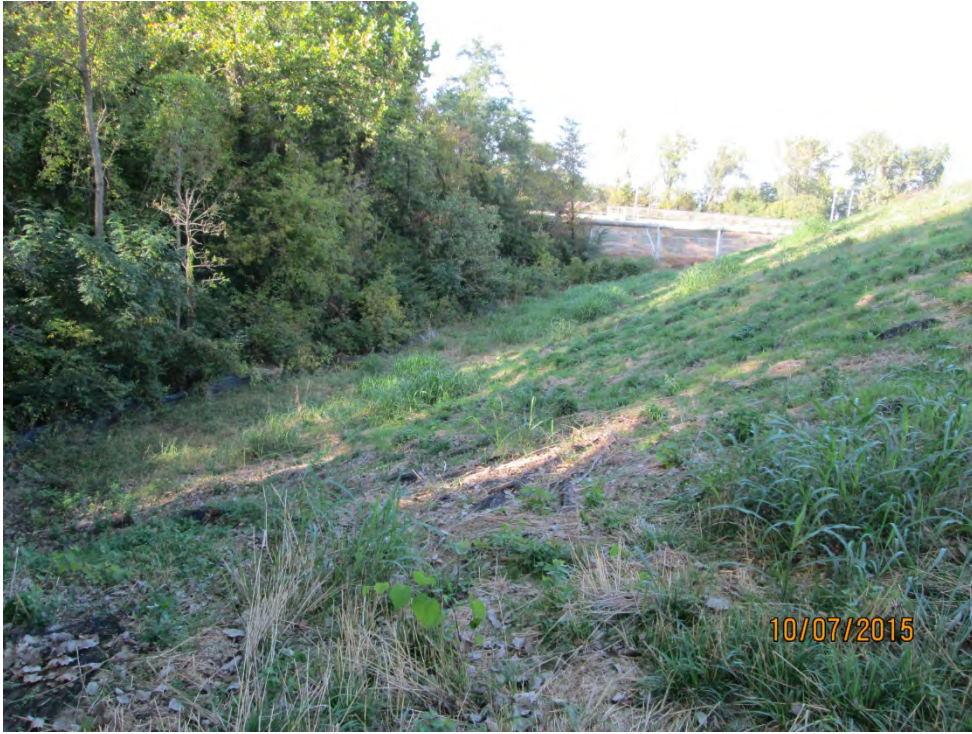
Photo No. 11  
West Berm Downstream Slope

The north and west downstream slopes are well protected against surface erosion by the heavy erosion control blankets placed during 2010 and 2012 construction activities and the vegetation that has become established since construction (Photos 10 and 11). On the north downstream slope, a continuous cover of grass exists that was generally well maintained. On the west downstream slope, vegetation was less established resulting in some areas where the grass was dead. In addition, there were patches where the grass was up to 18 inches in height (Photo 12).
