LOCATION RESTRICTIONS DEMONSTRATION REPORT CCR LANDFILL

La Cygne Generating Station

Presented to: Kansas City Power & Light Company La Cygne Generating Station La Cygne, Kansas

27218131.04 | October 2018

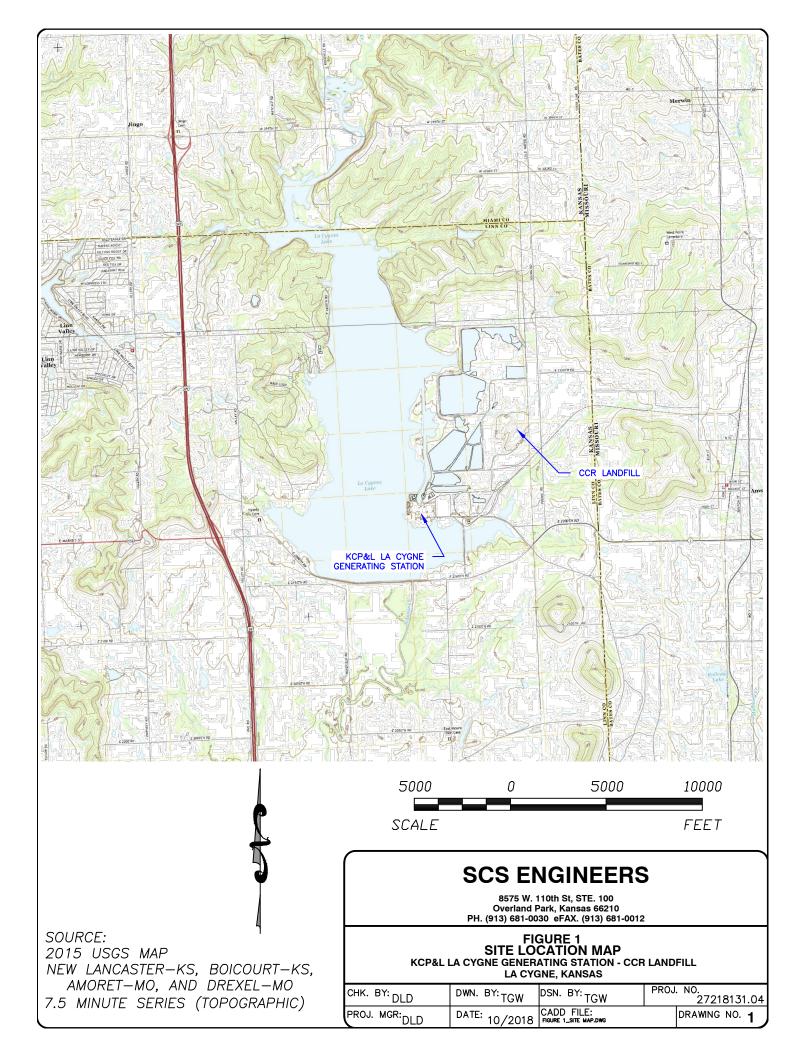
Figure 1 - Site Location Map

The Unit, which is an existing CCR landfill, is located at the La Cygne Generating Station near La Cygne, Kansas, as indicated in **Figure 1**.

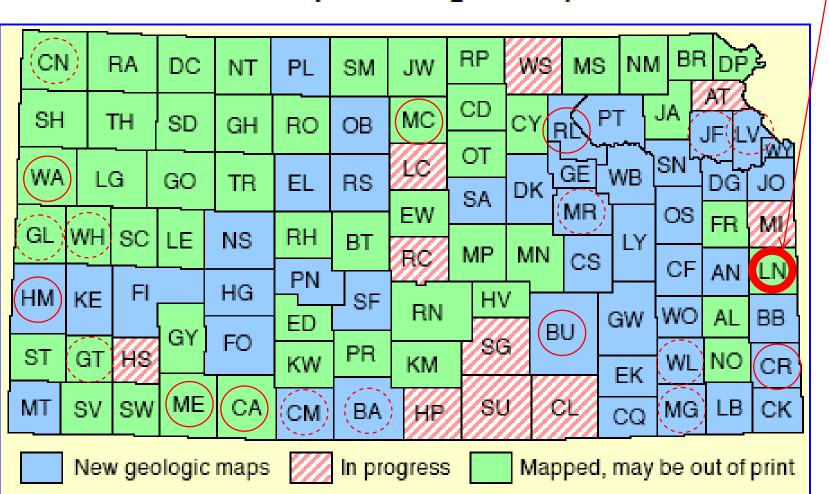
County Geologic maps

Kansas Geological Survey, Geologic History of Kansas Comments to <u>webadmin@kgs.ku.edu</u> Web version April 2006. Original publication date Dec. 1963. URL=http://www.kgs.ku.edu/Publications/Bulletins/162/10_app_d.html County key for counties discussed above. Note that Linn County was not discussed above.

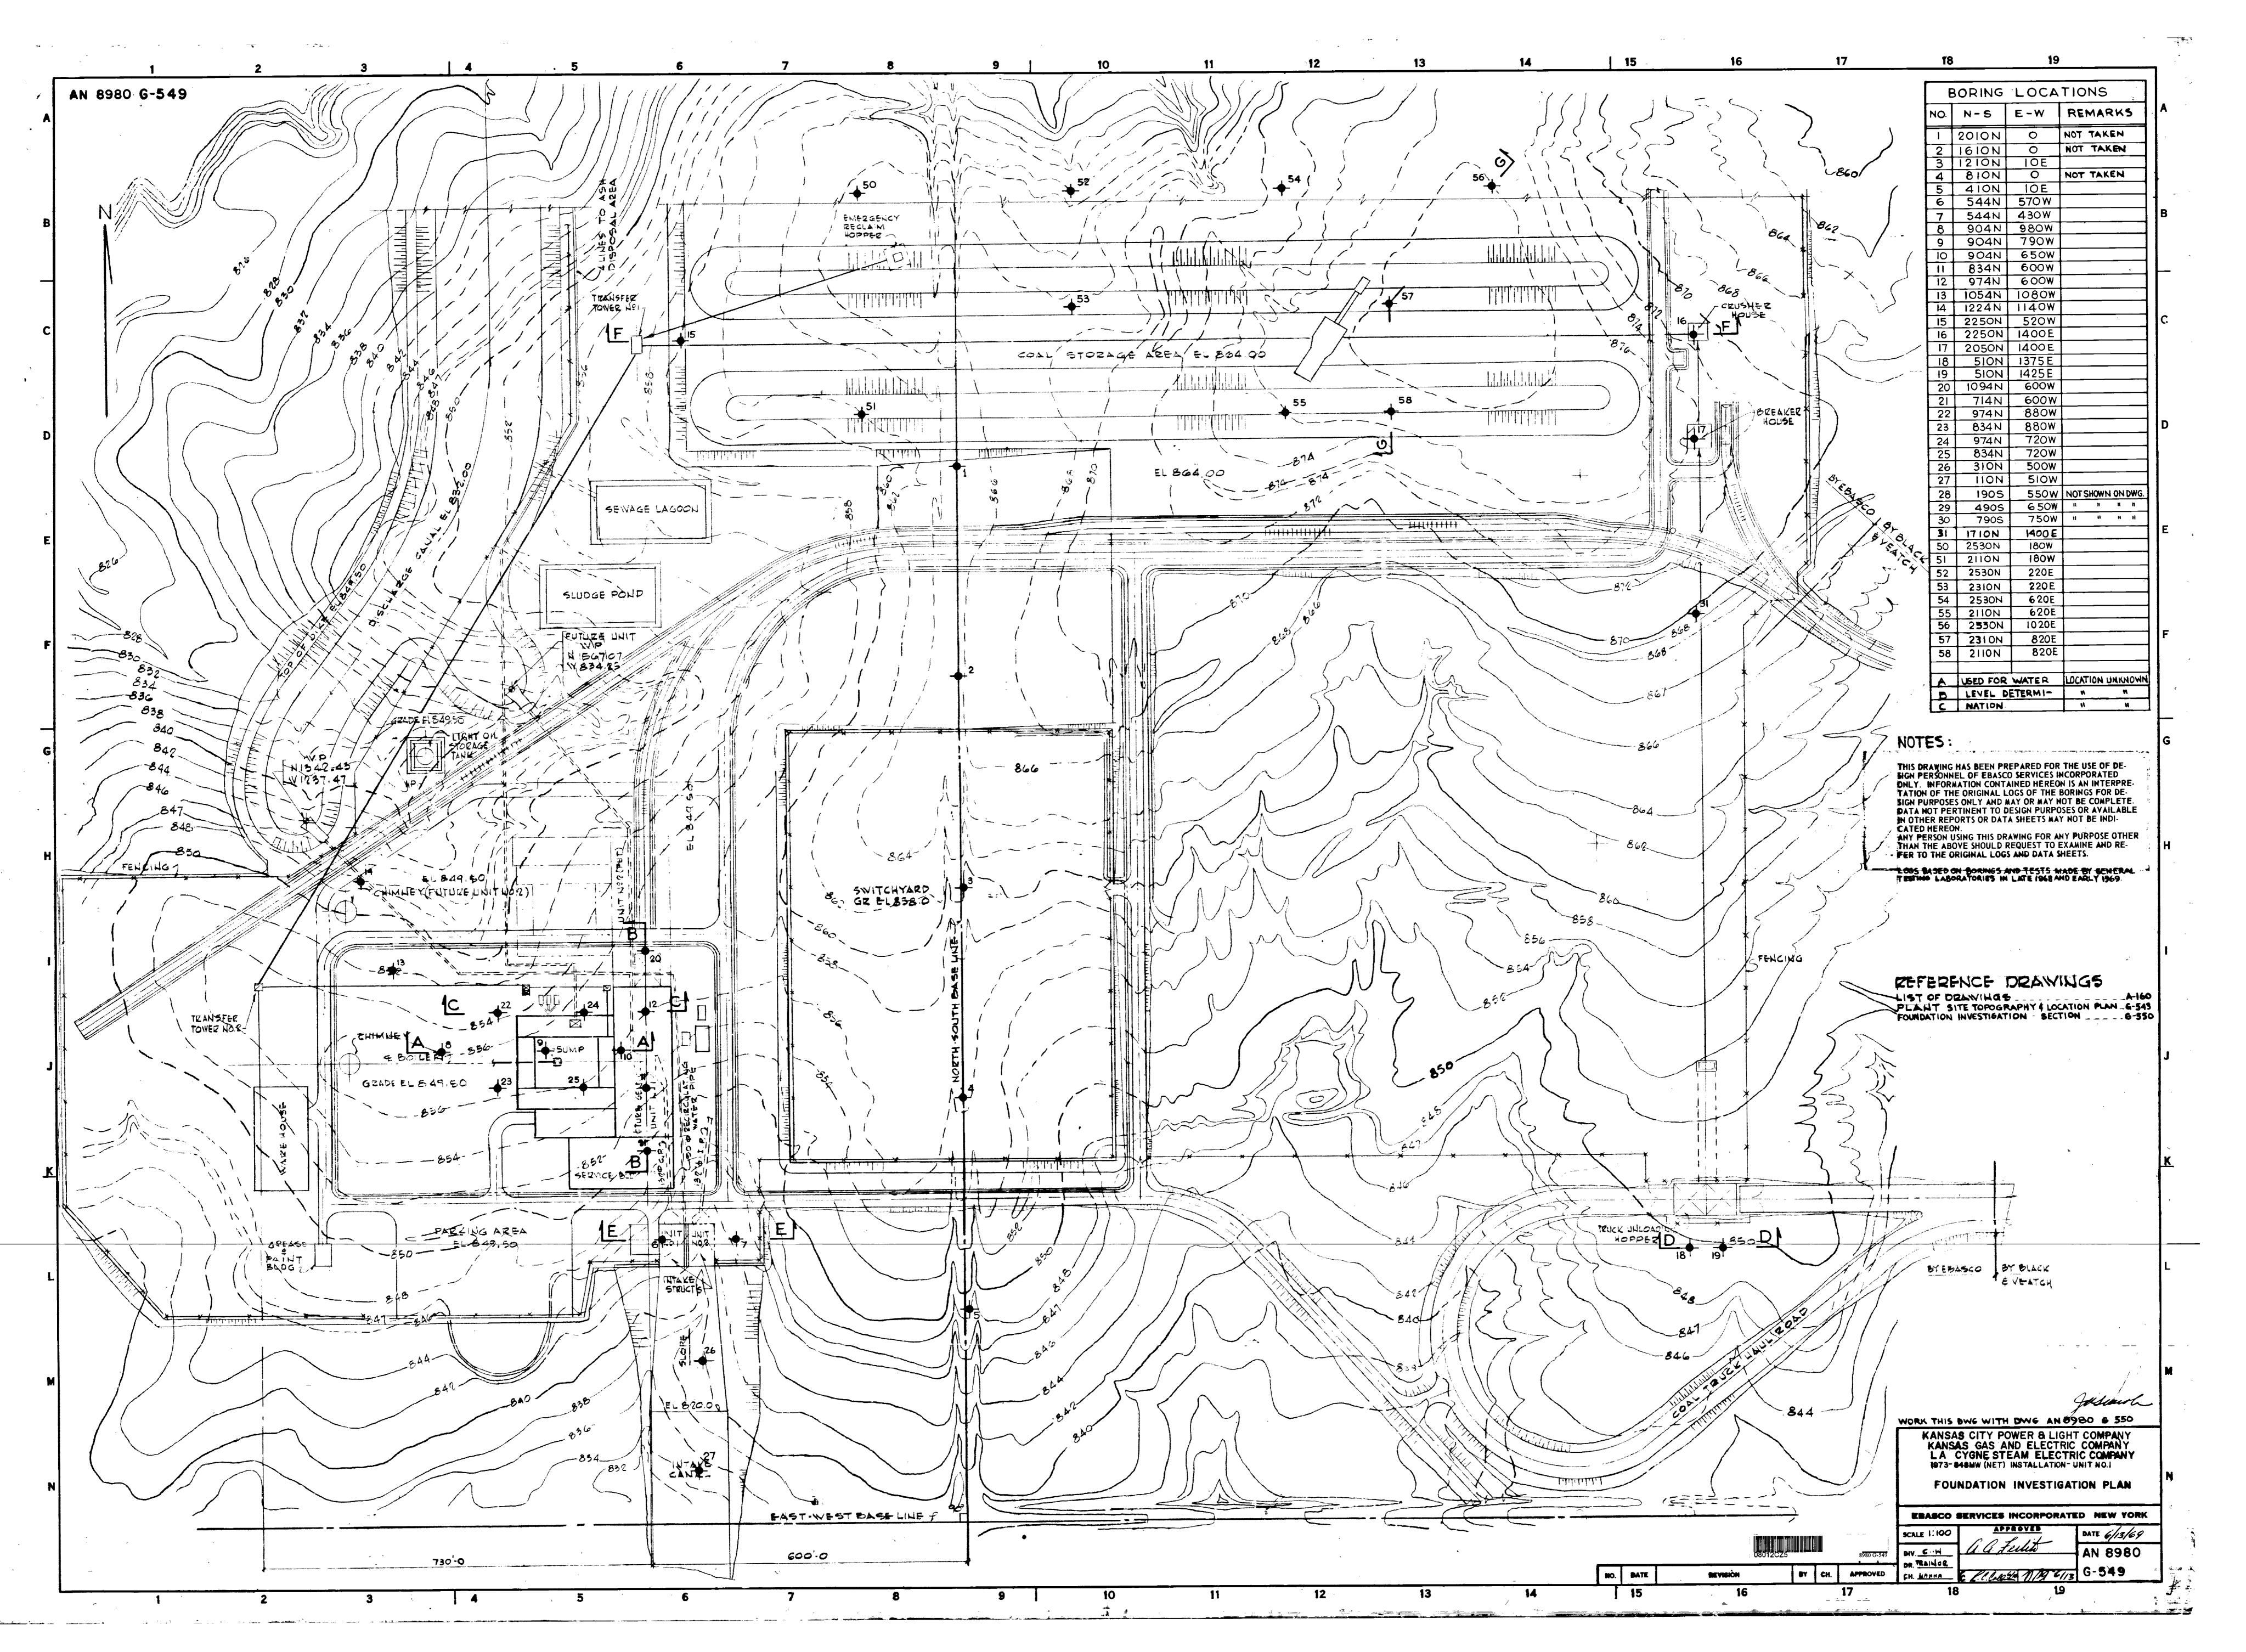
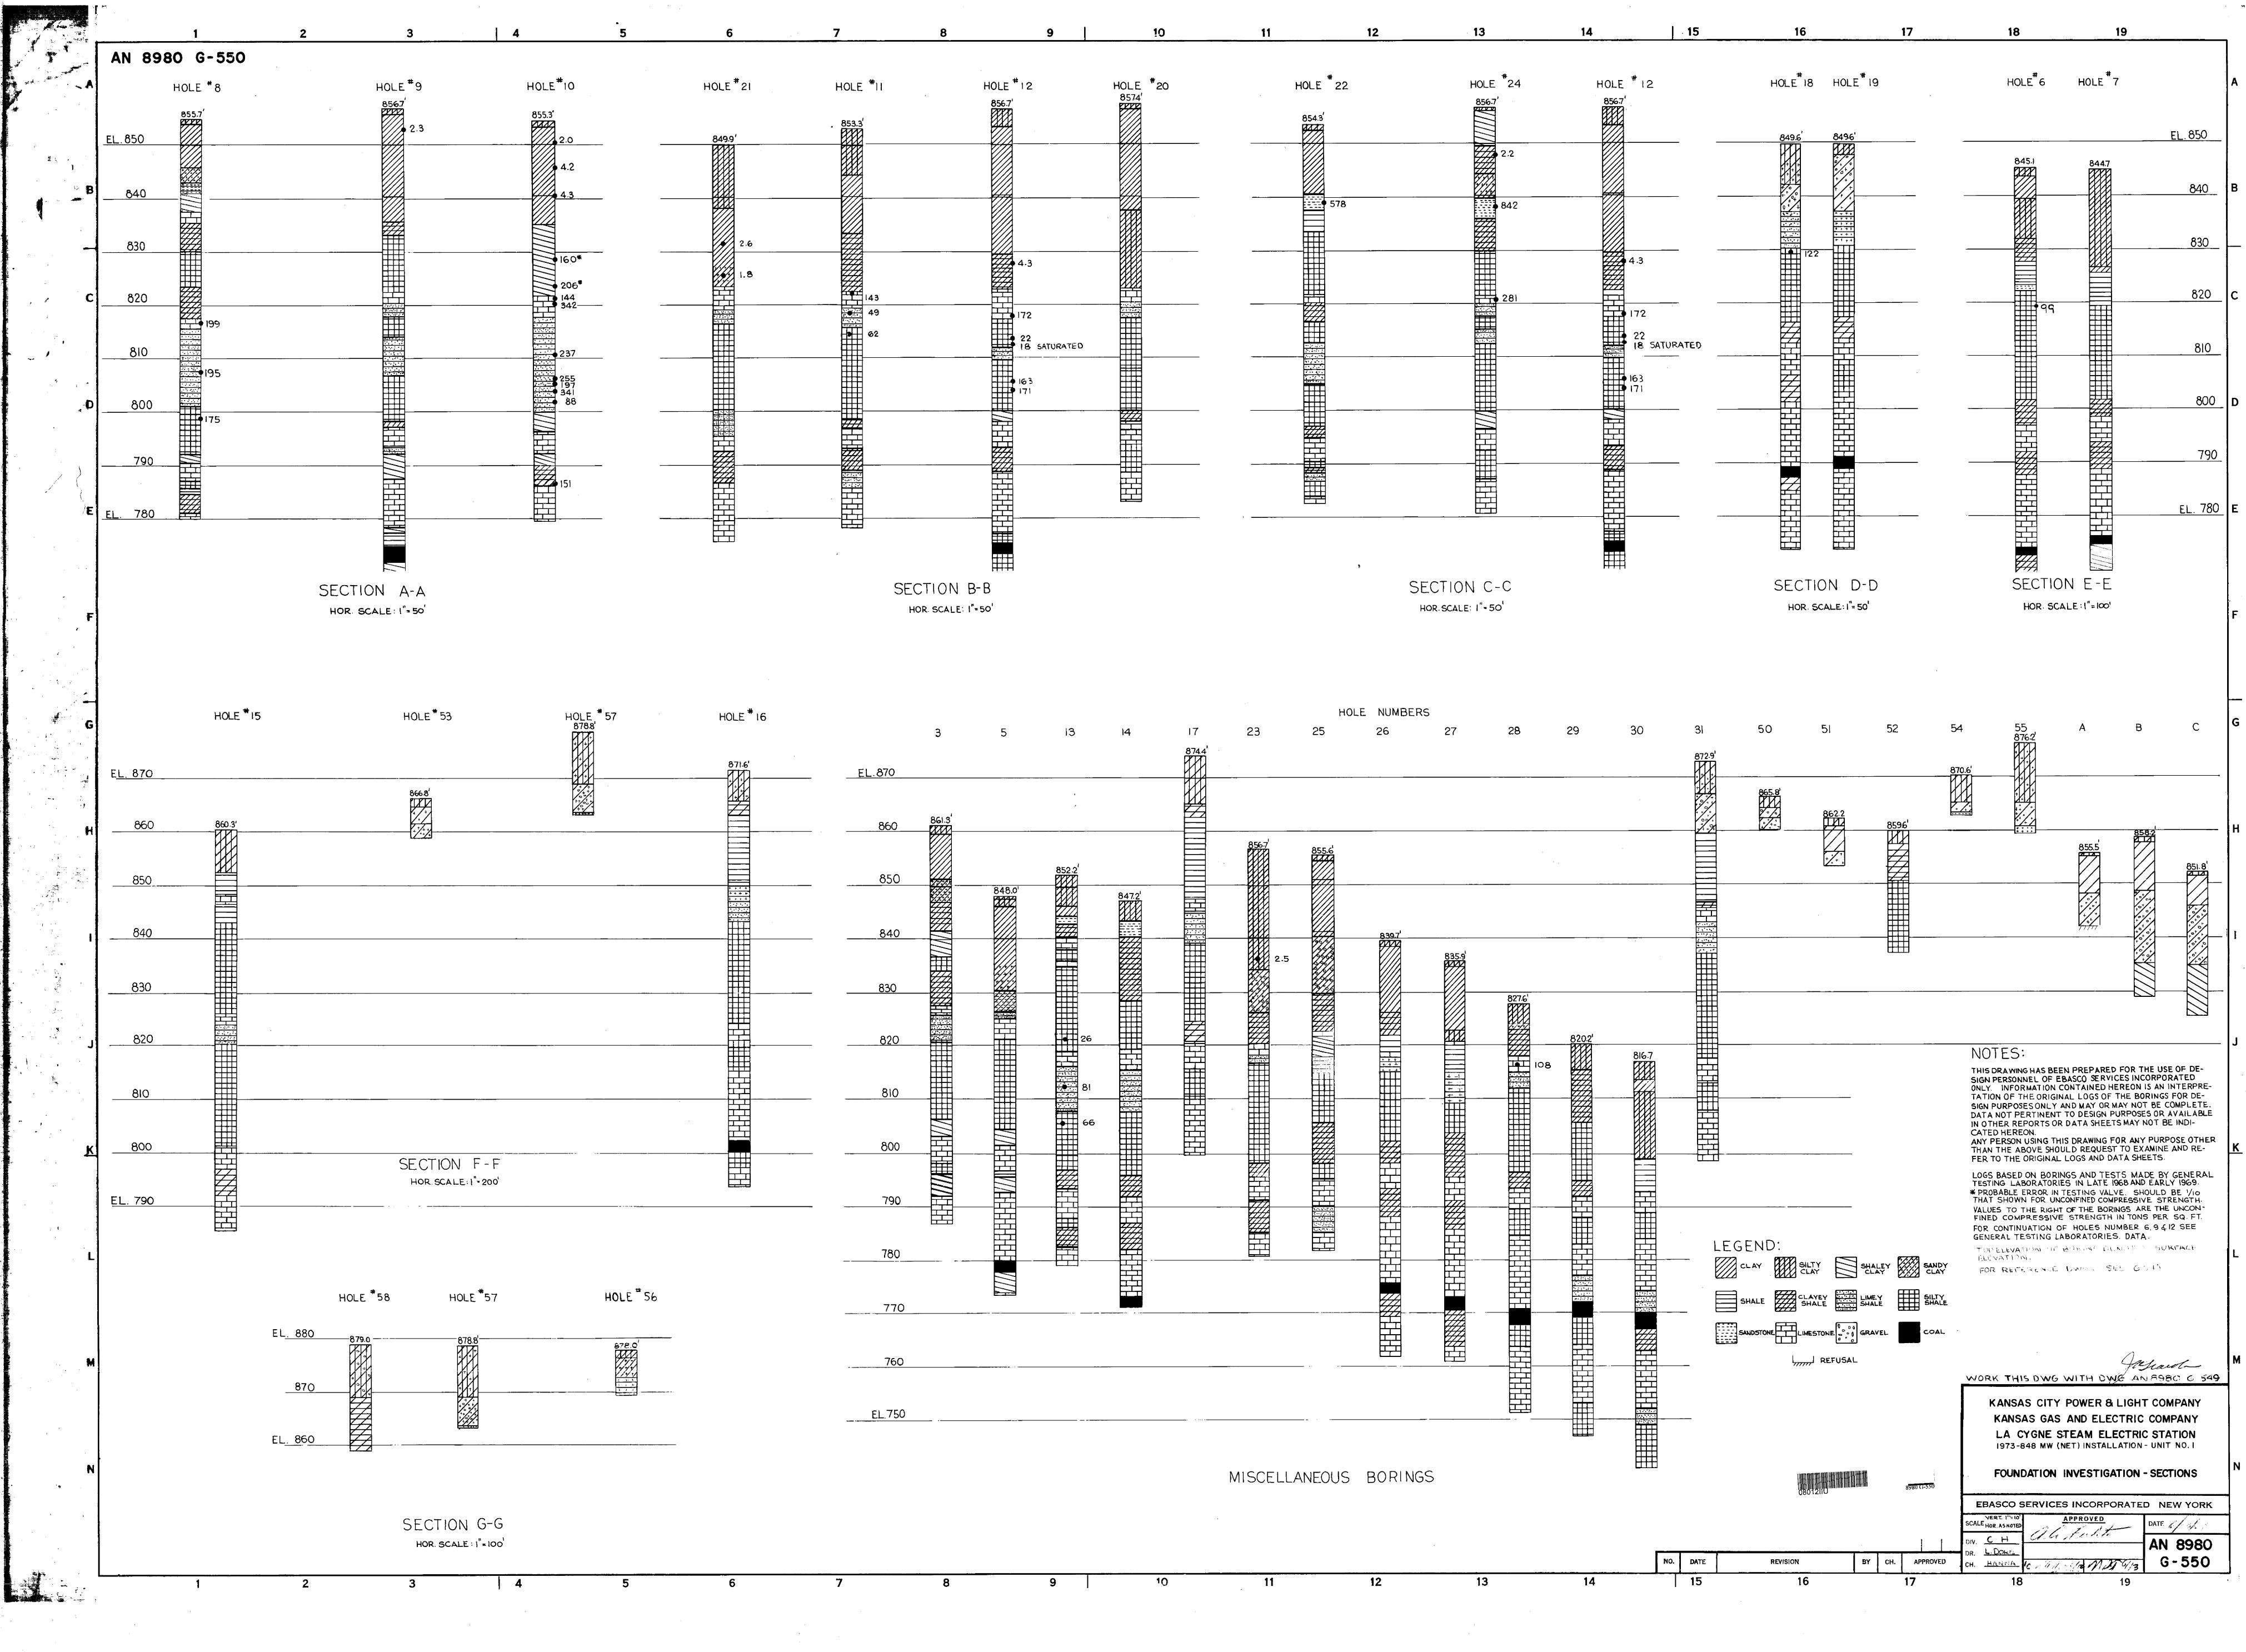
Ebasco Cross Sections from 1969

Pertinent documents and sections of documents reviewed include soil boring data for La Cygne (Ebasco, 1969) and a table with the location of nearby coal mines (Schoewe, 1955), provided in **Appendix A.3**.
